Leaning Tower of Pisa: Behaviour after Stabilization Operations

ABSTRACT: It is well known that the foundations of the Leaning Tower of Pisa were stabilised using the method of underexcavation to reduce the southward inclination of the Tower by about 10 percent in combination with controlling the seasonally fluctuating water table beneath the north side. Having been closed to the public since early in 1990, the Tower was re-opened in December 2001. The paper summarises the response of the Tower during the period of implementation of the stabilisation works. Monitoring of the movements of the Tower has been continuing and the observations obtained since 2001 are presented. It is shown that over the six years between 2003 and 2008 the induced rate of northward rotation of the Tower has been steadily reducing to less than 0.2 arc seconds per year. Similarly the rate of induced settlement of the Piazza. Piezometer measurements close to the north side of the foundation shows that the drainage system has been successful in stabilising the groundwater levels beneath the north side of the Tower's foundation. The paper concludes with a brief discussion on the possible future behaviour of t

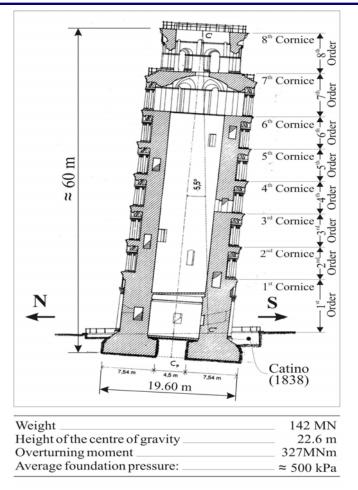
Figure 3. Cross-section in the plane of maximum inclination, situation in year 1993.

The purpose of this paper is to update the information on the behaviour of the Leaning Tower of Pisa after the work of stabilisation ended in 2001. The Tower of Pisa is the bell tower of the Cathedral and is one of the four monuments within the medieval Piazza dei Miracoli, three of which are shown in Fig. 1. Its construction began in 1173 and continued (with two long interruptions) for about two hundred years as illustrated in Fig. 2. The Tower is built as a hollow masonry cylinder surrounded by six colonnades with columns and vaults rising from the base cylinder. The outer and inner walls are faced with competent San Giuliano marble, while the annular cavity between is filled with miscellaneous rock fragments and mortar, forming a typical medieval infill masonry structure. The Tower commenced leaning southwards during the second construction stage as shown in Fig. 2, and thereafter its inclination continued to increase. Fig. 3 shows the cross section through the Tower in the plane of maximum tilt as it was in 1993 before the stabilisation work commenced. The average foundation pressure is 500kPa and a detailed computer analysis (Burland and Potts, 1994), indicates that the pressure at the south edge was about 1000kPa with the soil in a state of local yield, while the pressure at the north edge was close to zero.

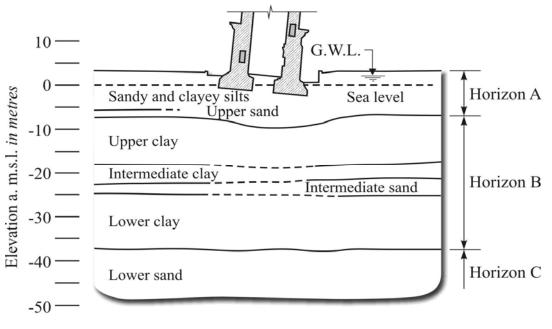
Figure 4. Soil profile.

The ground underlying the Pisa Tower consists of three formations as shown in Fig. 4. Horizon A, about 10m thick, is composed of soft estuarine deposits of sandy and clayey silts laid down under tidal conditions. Horizon B consists of soft sensitive normally consolidated marine clay extending to a depth of about 40m. Because it is very sensitive, this material loses much of its strength if disturbed. Horizon C is dense marine sand extending to a depth of about 60m. An upper perched water table in Horizon A is encountered between 1m and 2m below the level of Piazza dei Miracoli corresponding to elev. +3.0 above m.s.l. The contact between Horizon A and the marine clay of Horizon B is dished beneath the Tower, indicating that it experienced average settlements of between 3.0m and 3.5m.

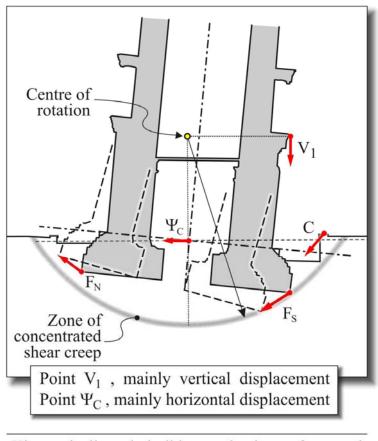
Figure 5. Motion of Tower foundation during steady creep (gradually accelerates) - Burland, Viggiani (1994).

Precise measurements begun in 1911 and show that during the twentieth century the inclination of the Tower has been increasing inexorably each year and the rate of tilt has doubled since the 1930's. In 1990 the increase of tilt was about 6 arc seconds per year which is equivalent to a horizontal movement at the top of about 1.5mm per year (Jamiolkowski, 2001). There has been much debate about the cause of this progressive increase in inclination. It has usually been attributed to creep in the underlying soft marine clay, the assumption being made that the south side was settling more than the north side. A careful study of the geodetic survey measurements going back to 1911 revealed a most surprising form of motion of the foundations which was radically different to previously held ideas. The theodolite measurements showed that the first cornice had not moved horizontally – apart from two occasions in 1934 and the early 1970s when man had intervened. Also, precision level measurements which commenced in 1928 showed that the centre of the foundation plinth had not displaced vertically relative to the surrounding ground. Therefore, the rigid body motion of the Tower could only be as shown in Fig. 5, with an instantaneous centre of rotation at the level of the first cornice vertically above the centre of the foundation. The direction of motion of points FN and FS are shown by vectors and it is clear that the foundation has been moving northwards with FN rising and FS sinking (Burland and Viggiani, 1994).

- 3. The pattern of ground movements depicted in Fig. 5 led to the important conclusion that the seat of the continuing long-term rotation of the Tower lies in Horizon A and not within the underlying marine clay as had been widely assumed in the past. It can therefore be concluded that the latter stratum must have undergone a considerable period of ageing since the end of construction. The ageing resulted in an increased resistance to yield a conclusion that proved to be of great importance in the successful computer modeling of the application of the temporary counterweight (Burland and Potts, 1994).

Kinematically admissible mechanism of ground movement, curvilinear concentrated shear creep zone passing through more plastic layer of horizon A

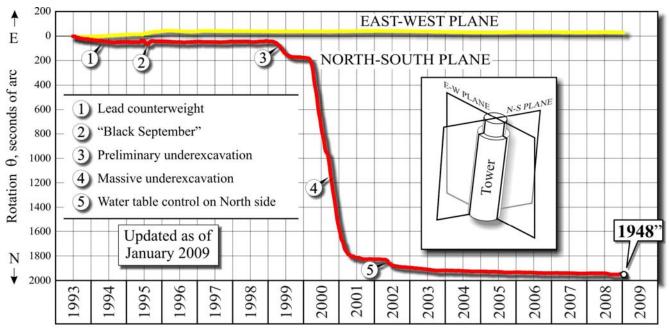
Figure 16. Rotation of Tower foundation as result of stabilization works.

As a result of the full underexcavation and of the implementation of the ground water control in Horizon A, the Tower foundation in mid 2002 had reduced its tilt by 1880 arc seconds - about 10% of the maximum value reached in 1993. In the succeeding six years the Tower has continued rotating northwards at a reducing rate, so that by September 2008 the

accumulated reduction of the foundation tilt reached 1948 arc seconds, see Fig.16. In the two years from September 2006 to September 2008 the residual rate of rotation northwards has reduced to less than 0.2 arc second per year.

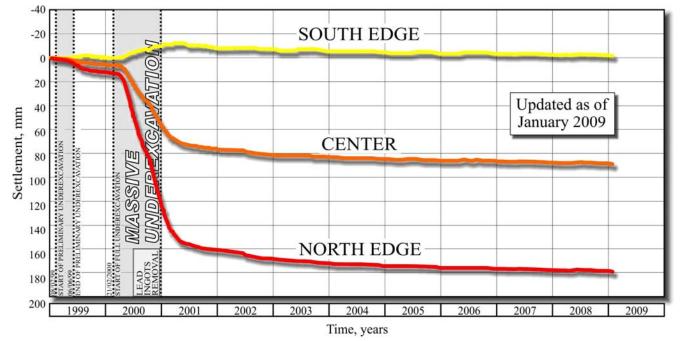
Figure 17. Settlement of Tower foundation as result of stabilization works.

The settlements of the south edge, centre and north edge of the foundation generated by the stabilisation operations, mainly by full underexcavation, are shown in Fig.17. In September 2008 the centre of the foundation had settled around 90mm and is continuing to settle at a rate that, over the last two years, is less than 1.0 mm/year. This is approaching the background rate of settlement of the Piazza due to the general subsidence of the Pisa plain. As regards the South edge of the foundation, it rose by about 15 mm during the underexcavation and has since settled around 12mm. This behaviour indicates that during underexcation, the axis of rotation was located under the imprint of the plinth and that the pressures due to the Tower weight at the south edge had reduced.

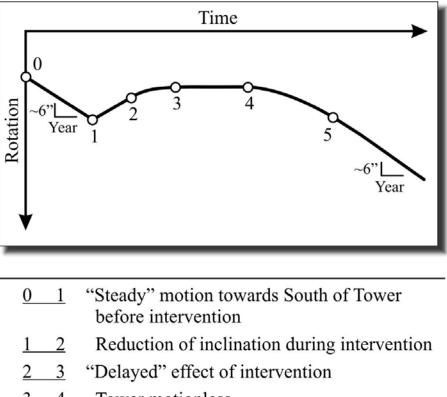
Figure 18. Expected future behaviour of the Leaning Tower of Pisa.

- <u>Pessimistic Scenario</u>. As illustrated in Fig. 18, after the completion of time effects of the underexcavation (period 2-3), the Tower will remain motionless for a period estimated as a few decades (period 3-4), followed by a possible resumption of the southward rotation. Initially this southward rate of rotation will be very much less than the 6 arc second per year that existed before the stabilisation works. However the rotation rate will gradually increase (period 4-5) and may approach again, after a very long time, a value close to 6 arc seconds. In what period of time this will occur is difficult to estimate. However, considering that the stabilisation works brought the Tower inclination back to the situation that existed at the beginning of the XIX century, the authors believe that the period of time for the Tower to return to its 1993 inclination will be at least 200 years.

- <u>3</u> <u>4</u> Tower motionless
- <u>4</u> <u>5</u> Southward rotation resumed
- 5____ Rotation rate as before intervention
