# SURFACE-WATER FIELD TECHNIQUES

## Verified Roughness Characteristics of Natural Channels

Most hydraulic computations related to indirect estimates of discharge require an evaluation of the roughness characteristics of the channel. In the absence of a satisfactory quantitative procedure this evaluation remains chiefly an art. The ability to evaluate roughness coefficients must be developed through experience. One means of gaining this experience is by examining and becoming acquainted with the appearance of some typical channels whose roughness coefficients are known.

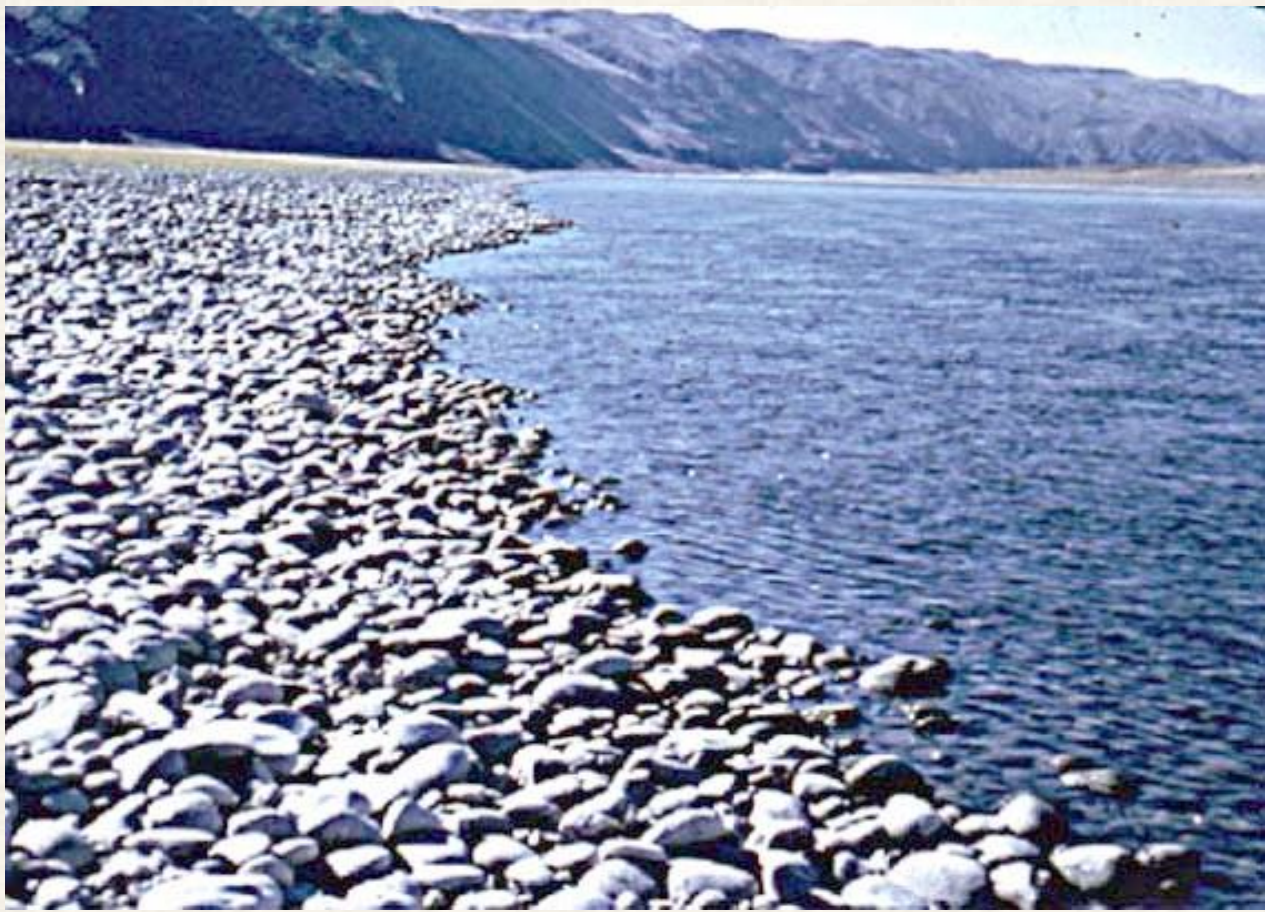
Photo 66: Upstream view along right bank from section 3, Columbia River at Vernita, Washington.

- Gage height 48.33 ft at Trinidad gage:  
29.5 ft (different datum) at  
section 1.
- Peak discharge 406,000 cfs
- Computed roughness  
coefficient Manning  $n = 0.024$
- Description of channel Bed consists of  
slime-covered cobbles and  
gravel. The straight and  
steep left bank is composed  
of cemented cobbles and  
gravel. The gently sloping  
right bank consists of  
cobbles set in gravel and is  
free of vegetation.

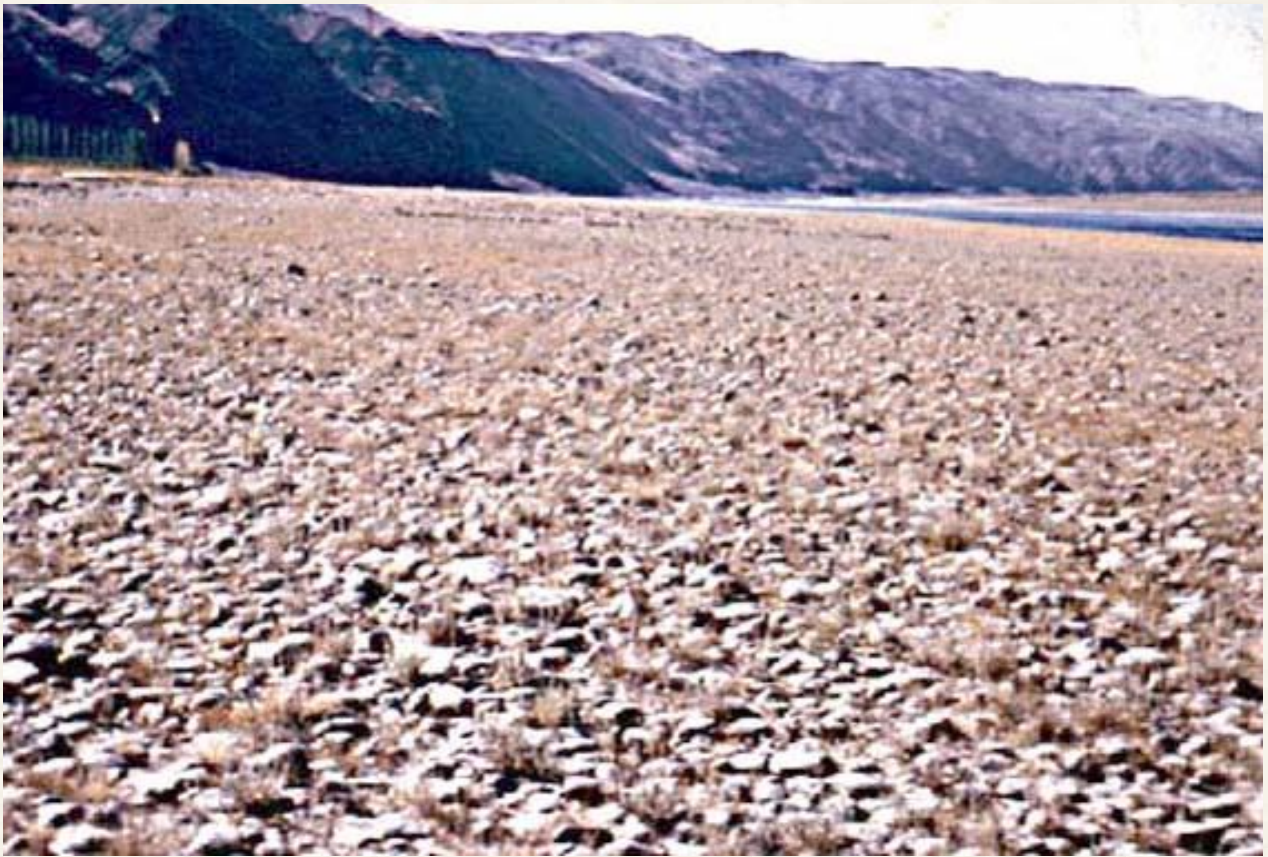
Photo 67: Upstream view from top of bank at section 3, Columbia River at Vernita, Washington.

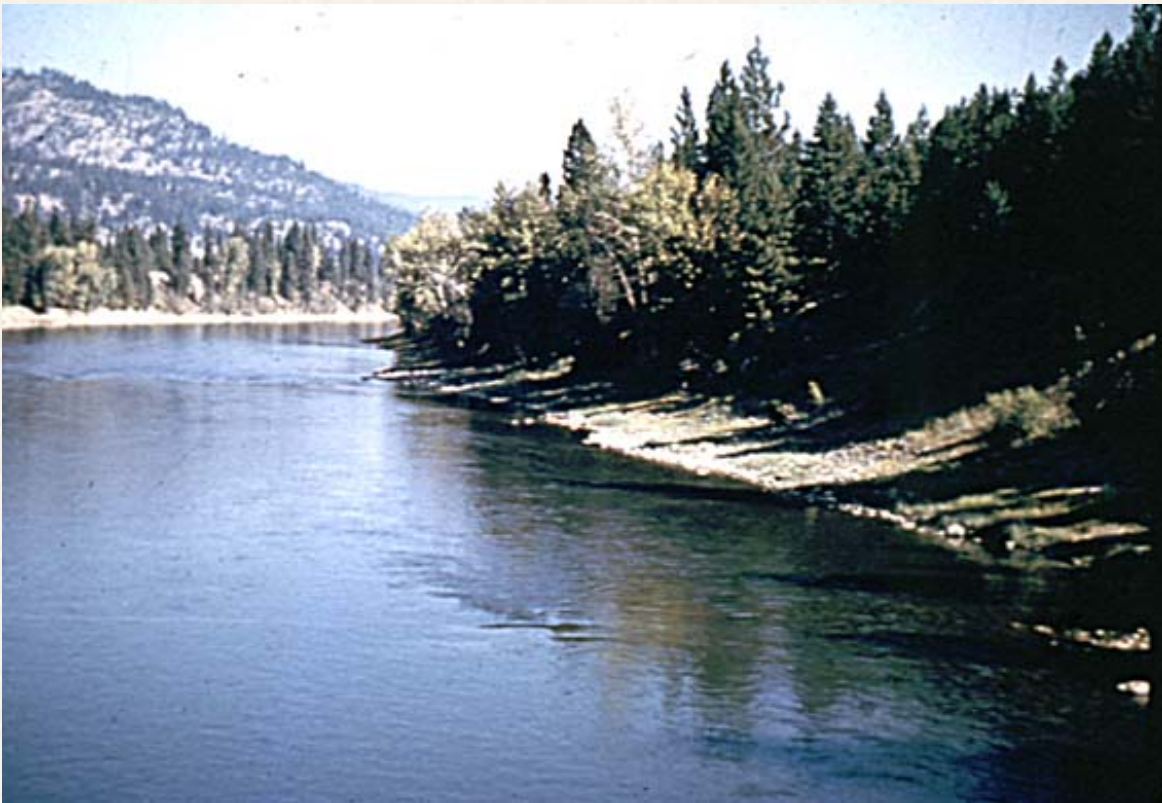
Photo 22: Downstream along right bank from section 2, Clark Fork at St. Regis, Montana.

Bed consists of well-rounded boulders;  $d_{50} = 135$  mm,  $d_{84} = 205$  mm. Banks are composed of gravel and boulders, and have tree and brush cover.

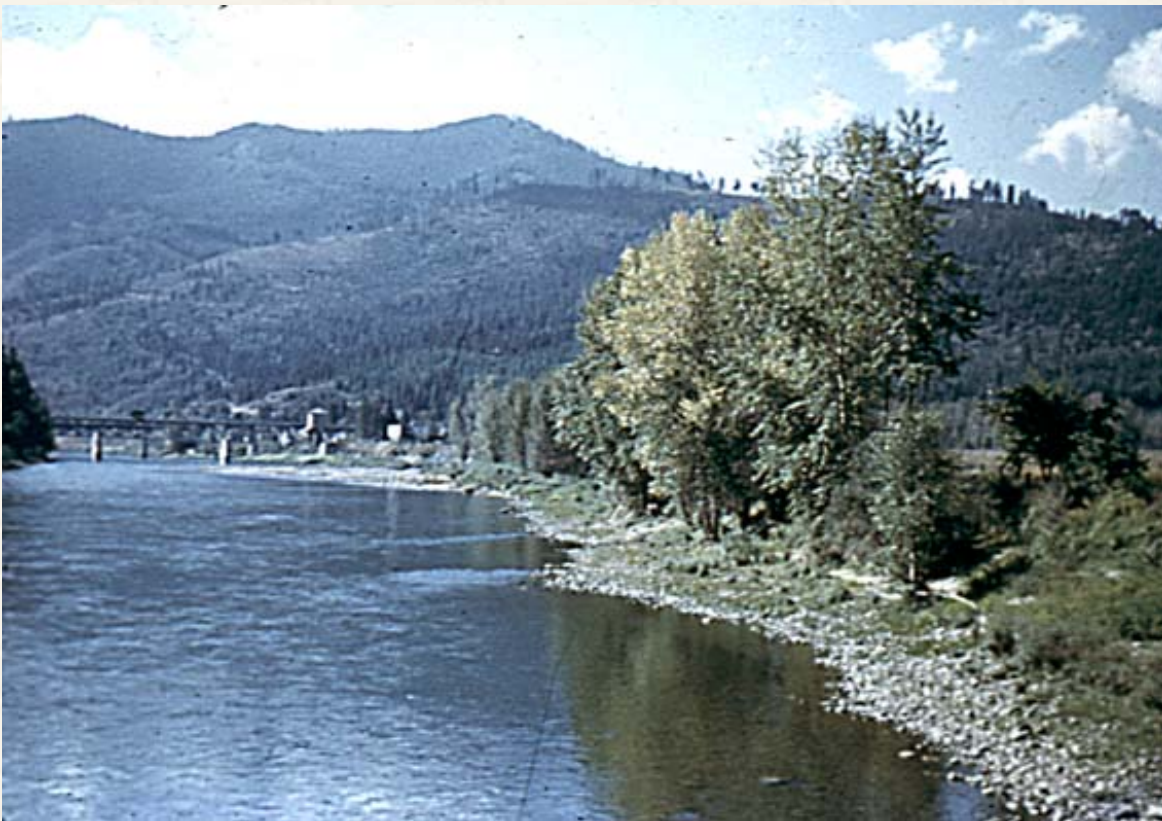
Photo 23: Upstream along left bank from section 2, Clark Fork at St. Regis, Montana.

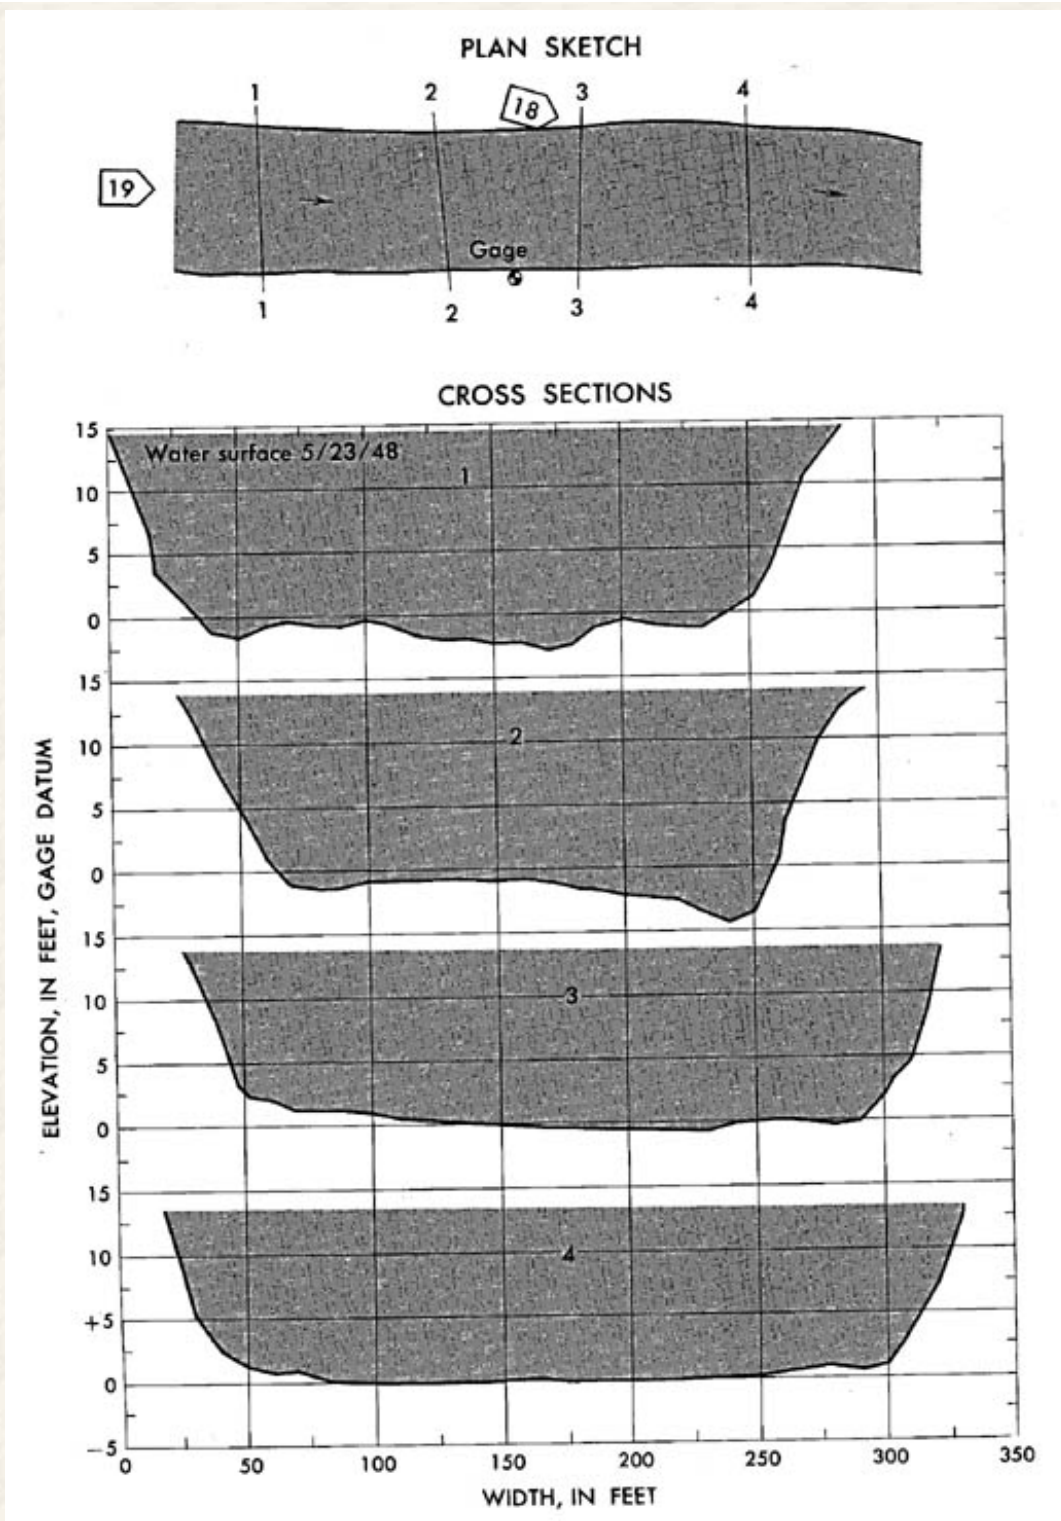
Plan sketch and cross sections, Clark Fork above Missoula, Montana.

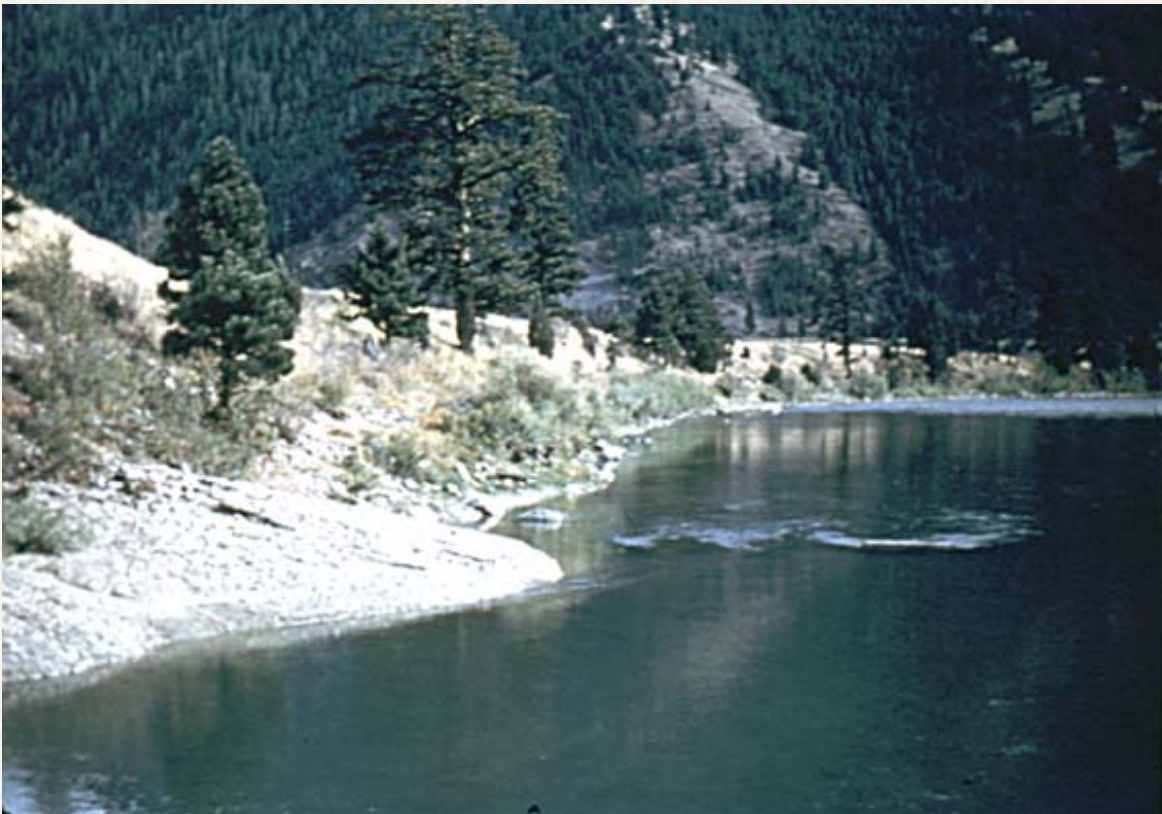
Photo 18: Downstream along left bank from above section 3, Clark Fork above Missoula, Montana.

Bed is composed of sand, gravel, and boulders;  $d_{50} = 175$  mm,  $d_{84} = 325$  mm.

Thick undergrowth is along right bank and along the left bank in the lower part of the reach.

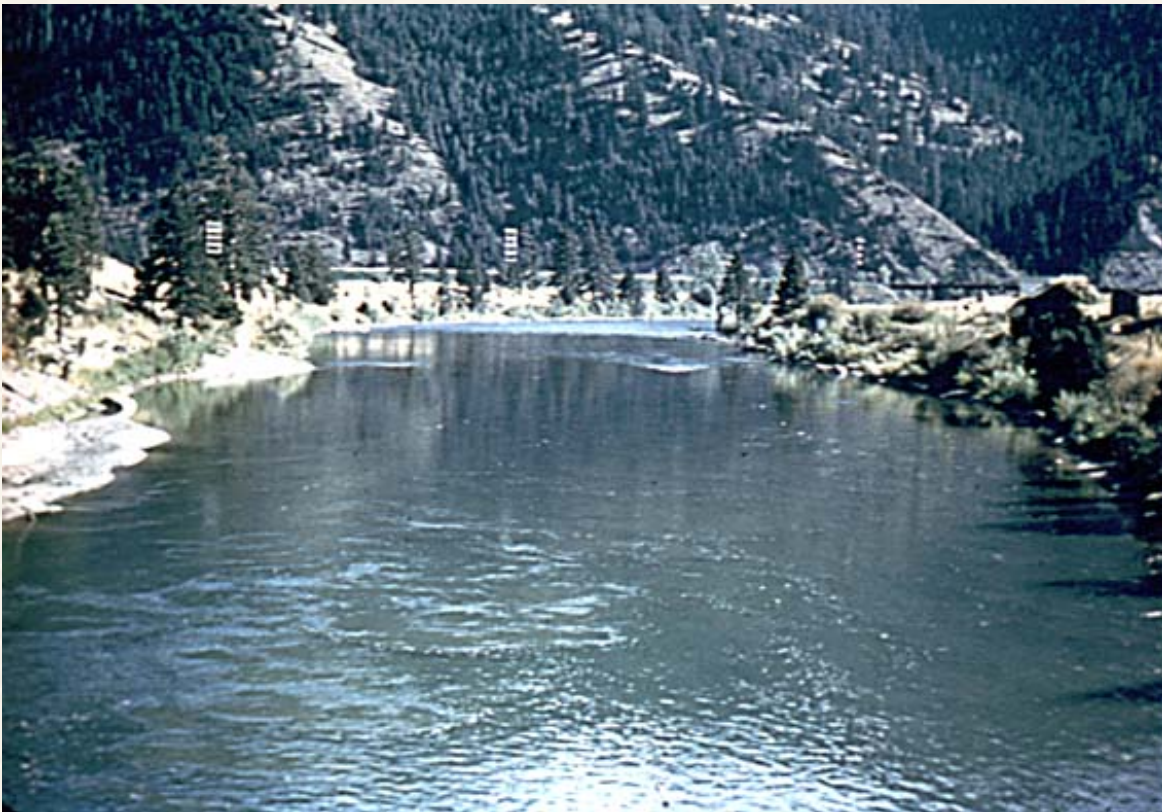
Photo 19: Downstream through reach from bridge 400 ft above section 1, Clark Fork above Missoula, Montana.

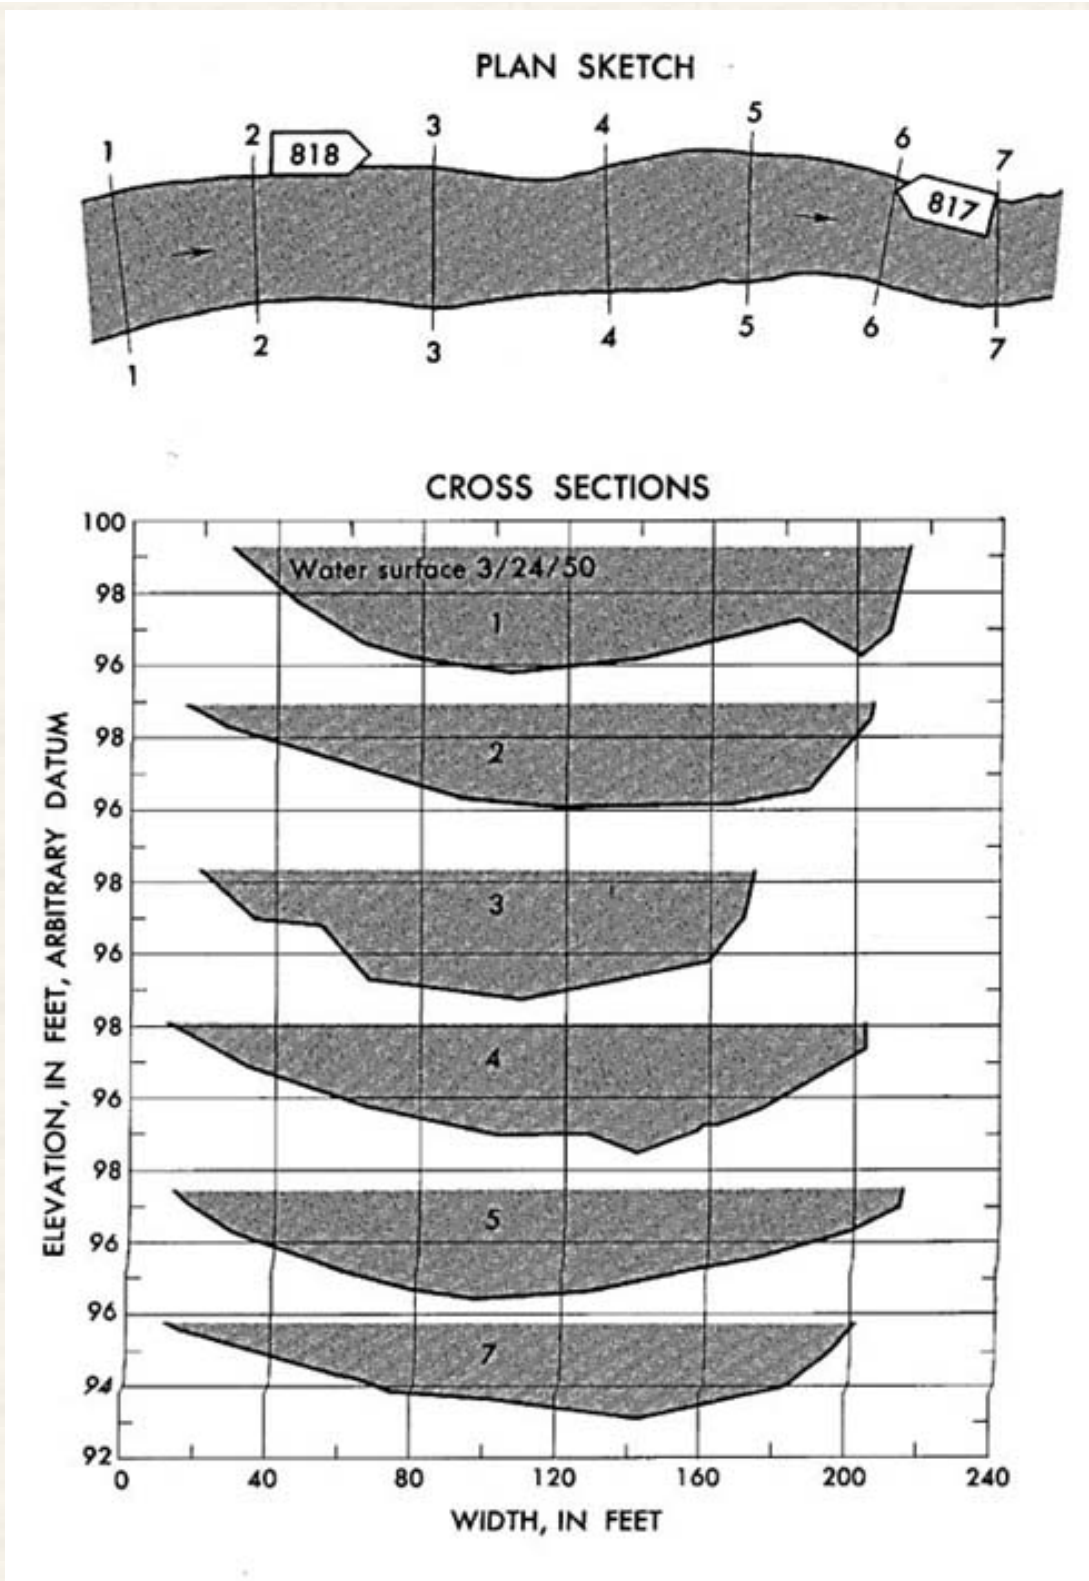
Plan sketch and cross sections, Salt River below Stewart Mountain Dam, Arizona.

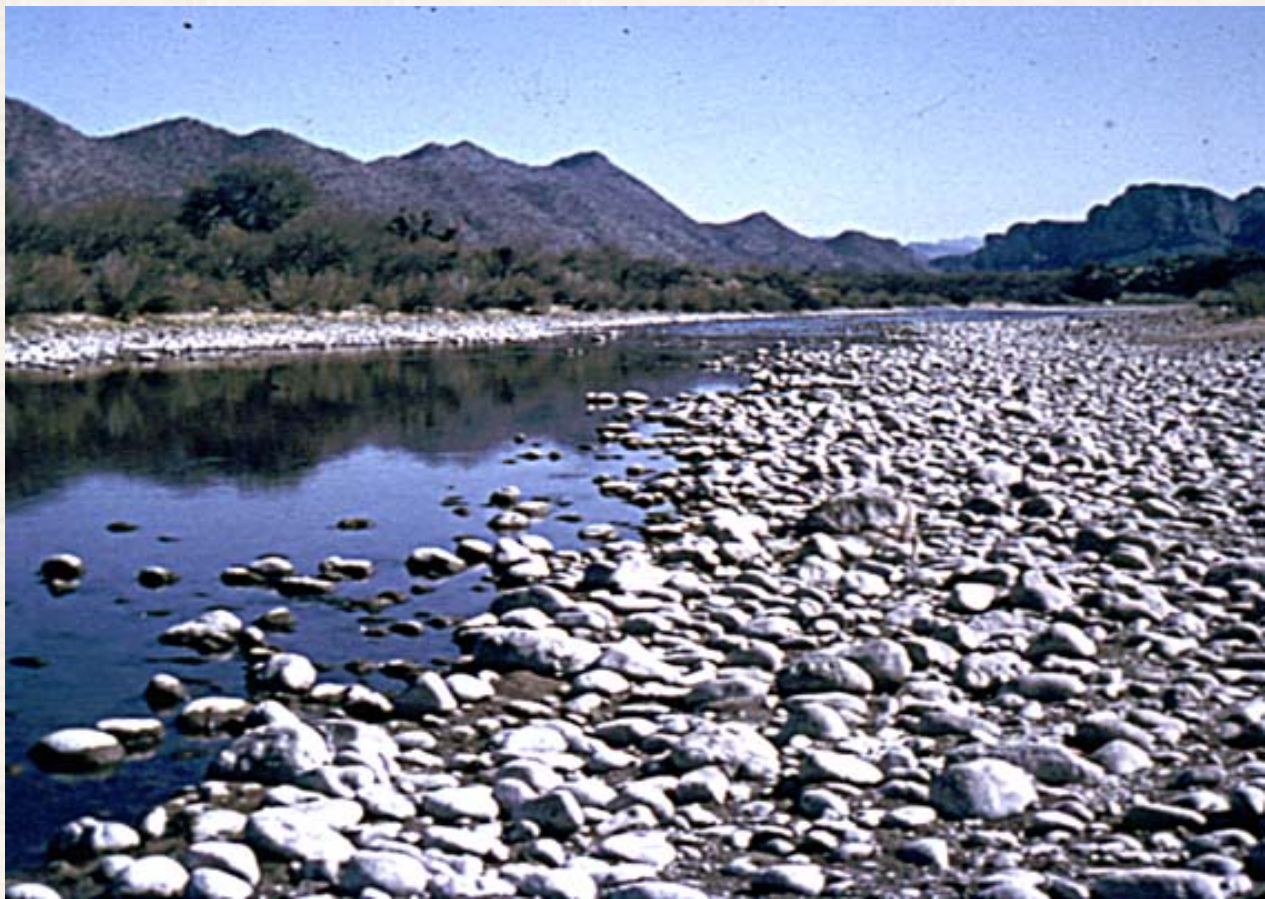
Photo 817: Upstream along left bank from below section 6, Salt River below Stewart Mountain Dam, Arizona.

Bed and banks consist of smooth cobbles 4 to 10 inches in diameter, average diameter about 6 inches. A few boulders are as much as 18 inches in diameter.

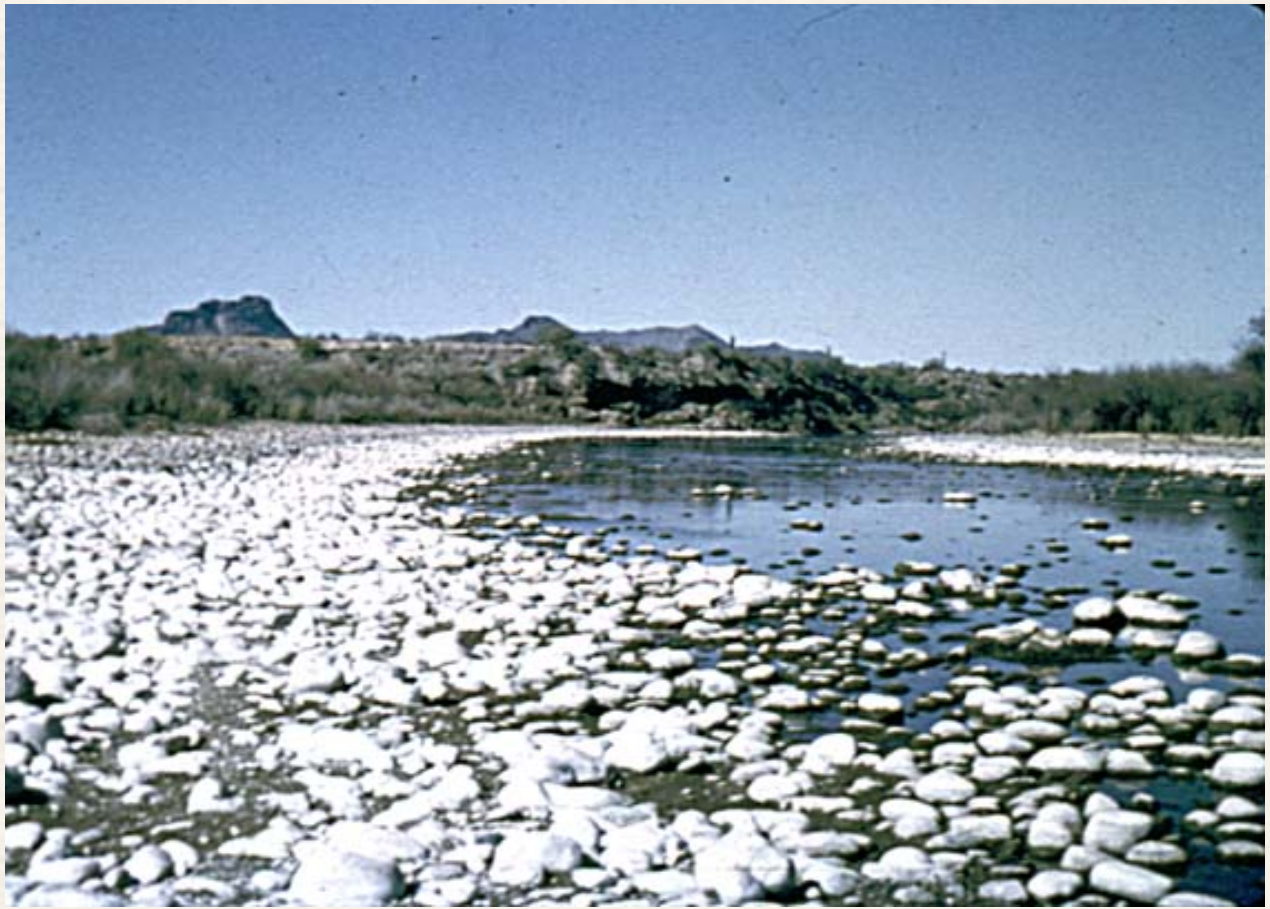
Photo 818: Downstream along left bank from section 2, Salt River below Stewart Mountain Dam, Arizona.

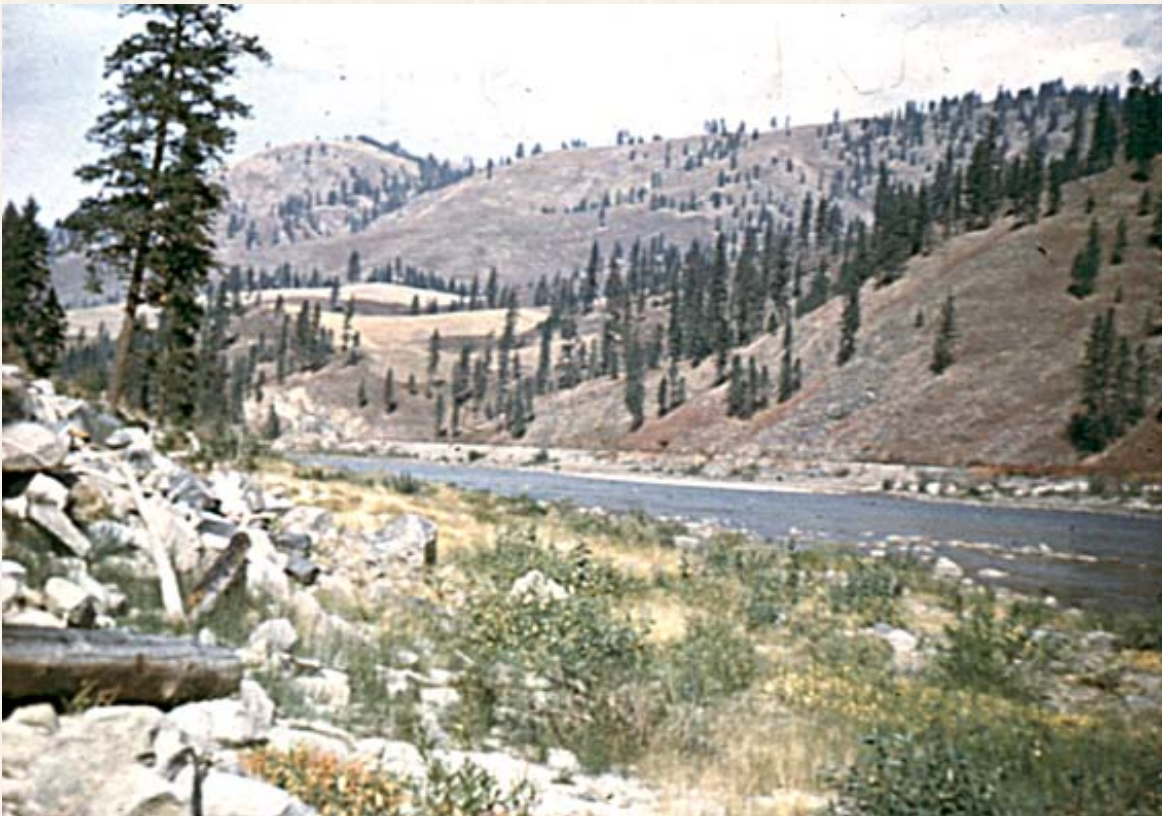
Photo 29: Downstream along left bank from above section 1, Clearwater River at Kamiah, Idaho.

- Computed roughness coefficient      Manning  $n = 0.033$
- Description of channel      Bed is composed of gravel and boulders with some exposed bedrock. Channel is bordered by railroad on the right and highway on the left. Banks are gravel and rock and have light vegetation.

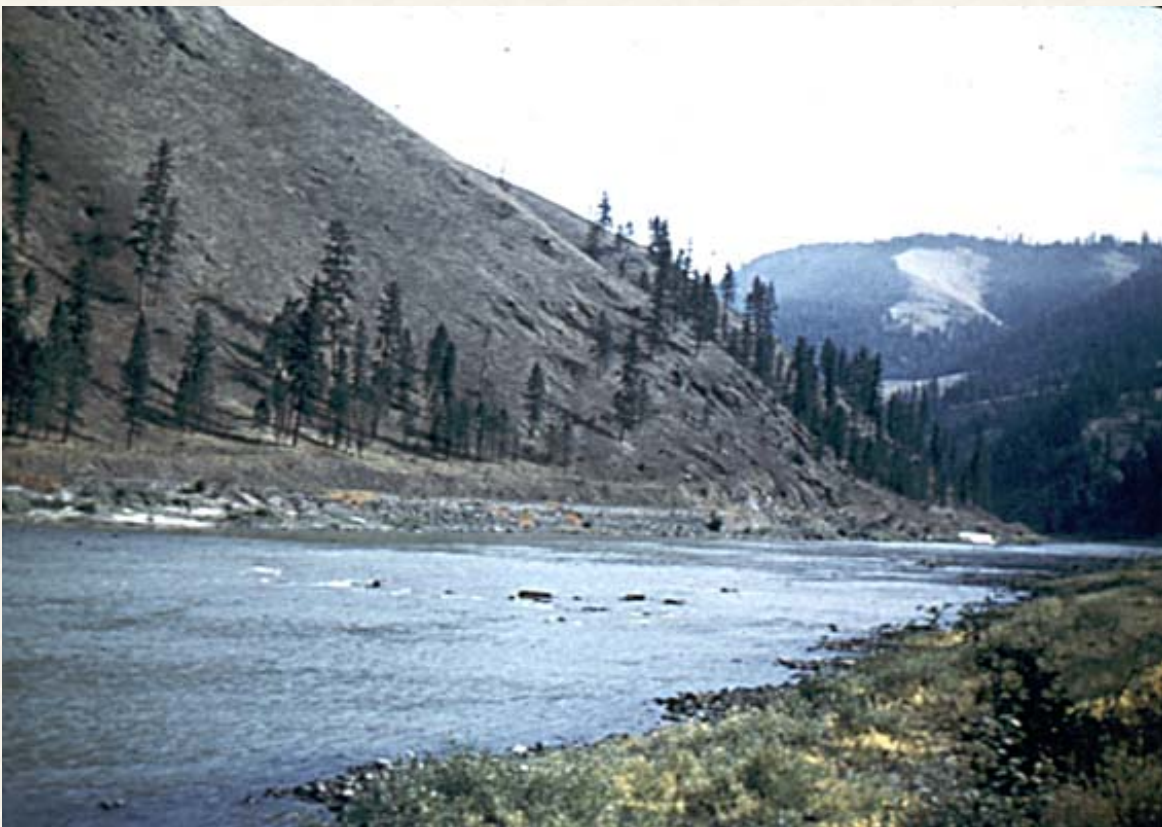
Photo 32: Upstream from left bank at section 3, Clearwater River at Kamiah, Idaho.

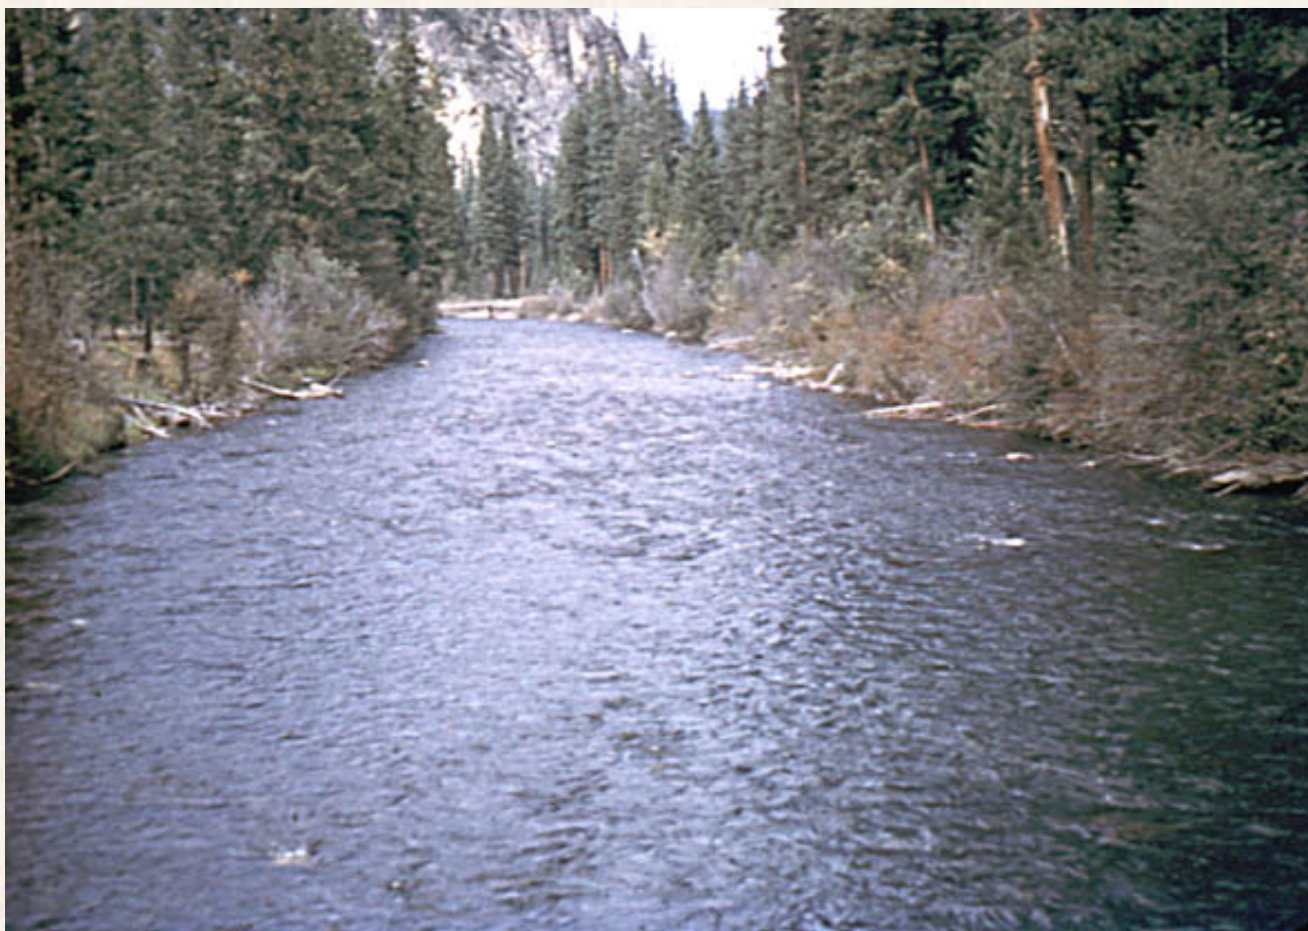
Photo 175: Downstream from section 1, West Fork Bitterroot River near Conner, Montana.

- Gage height 6.08 ft at gage: 3.27 ft at section 1
- Peak discharge 3,880 cfs
- Computed roughness coefficient Manning  $n = 0.036$
- Description of channel Bed is gravel and boulders;.  $d_{50} = 172$  mm,  $d_{84} = 265$  mm. The left bank is lined with overhanging bushes. The right bank is lined with trees.

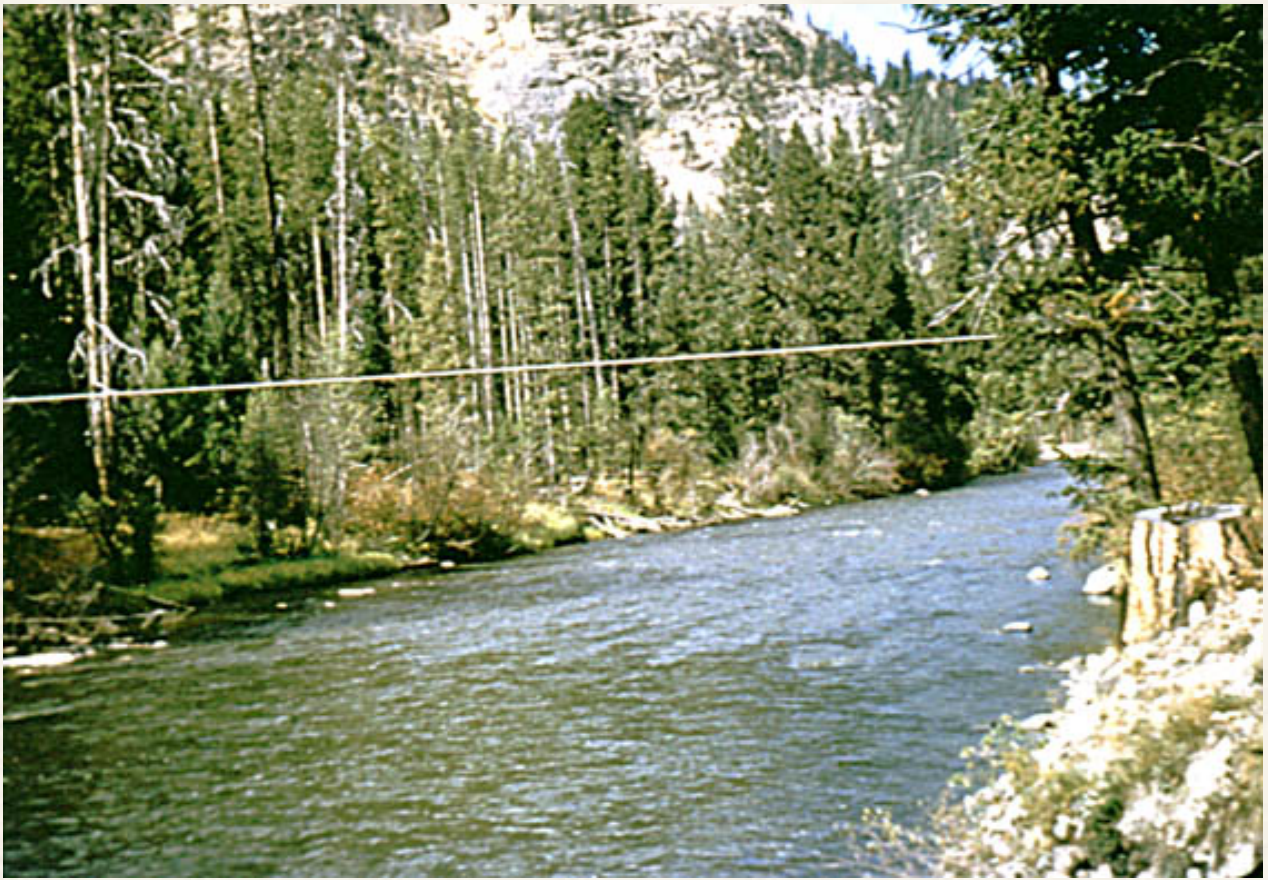
Photo 177: Downstream from right bank above section 1, West Fork Bitterroot River near Conner, Montana.

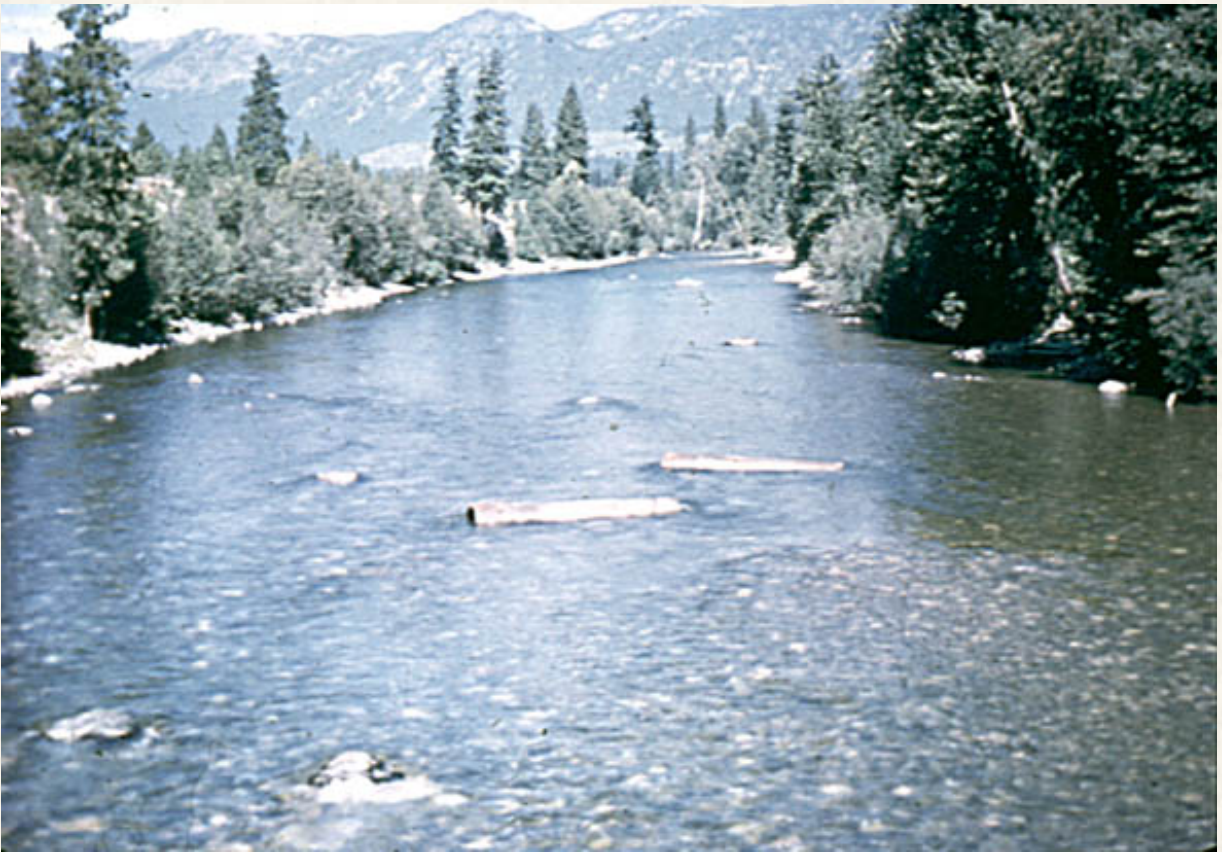
Photo 169: Downstream from above section 1, Wenatchee River at Plain, Washington.

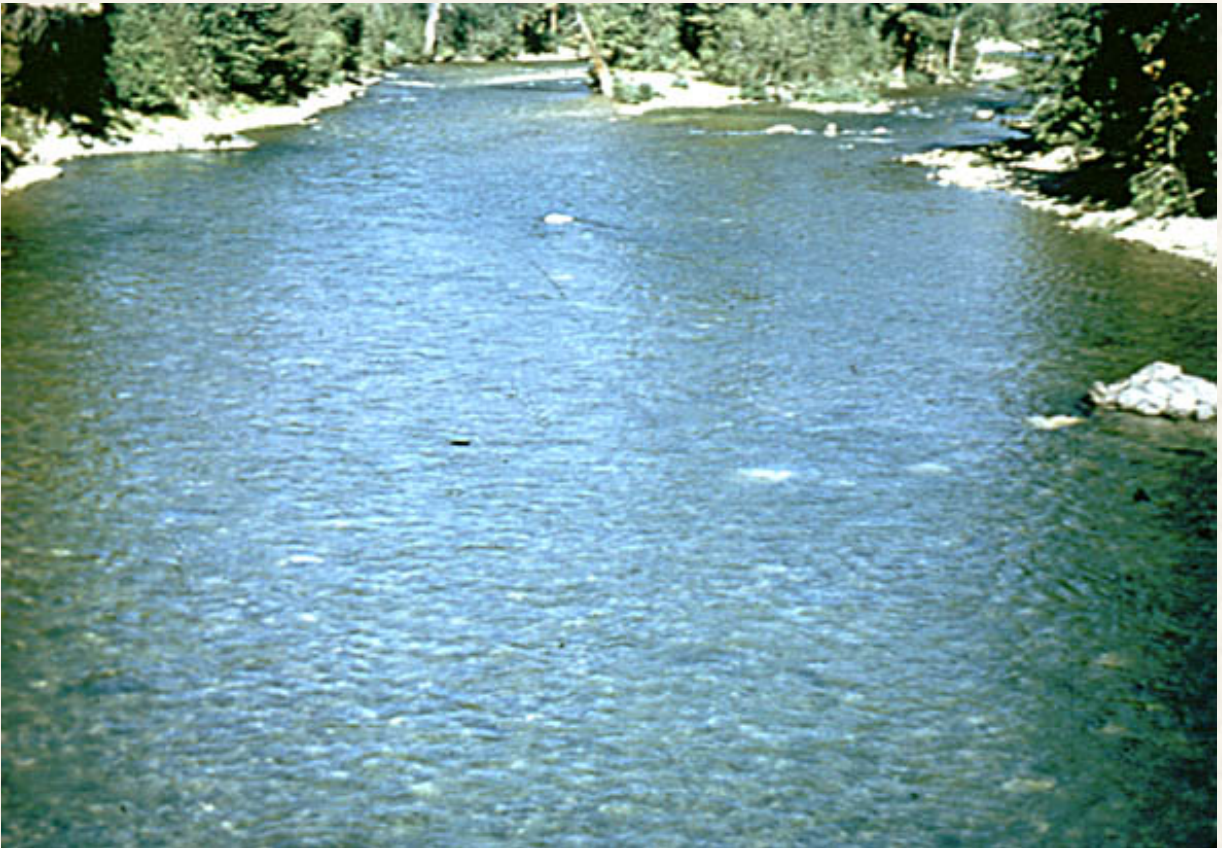
Photo 173: Downstream from section 2, Wenatchee River at Plain, Washington.

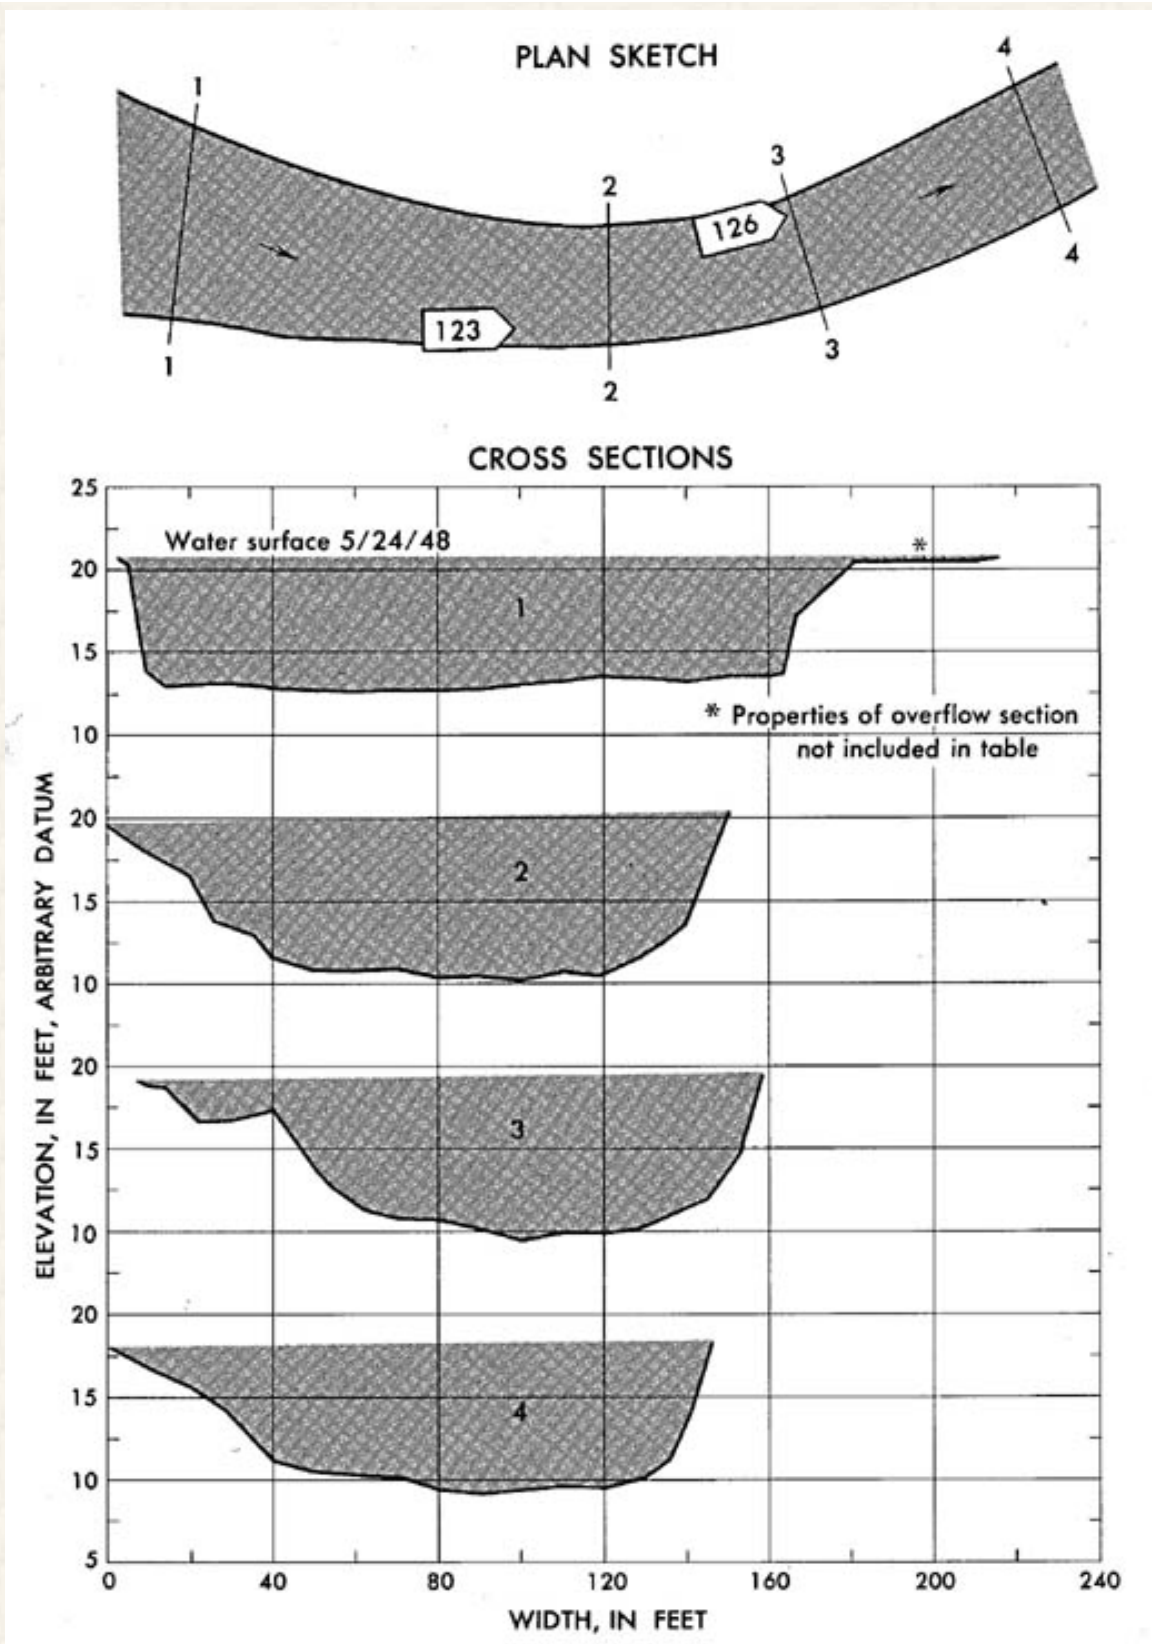
Plan and cross sections, Moyie River at Eastport, Idaho.

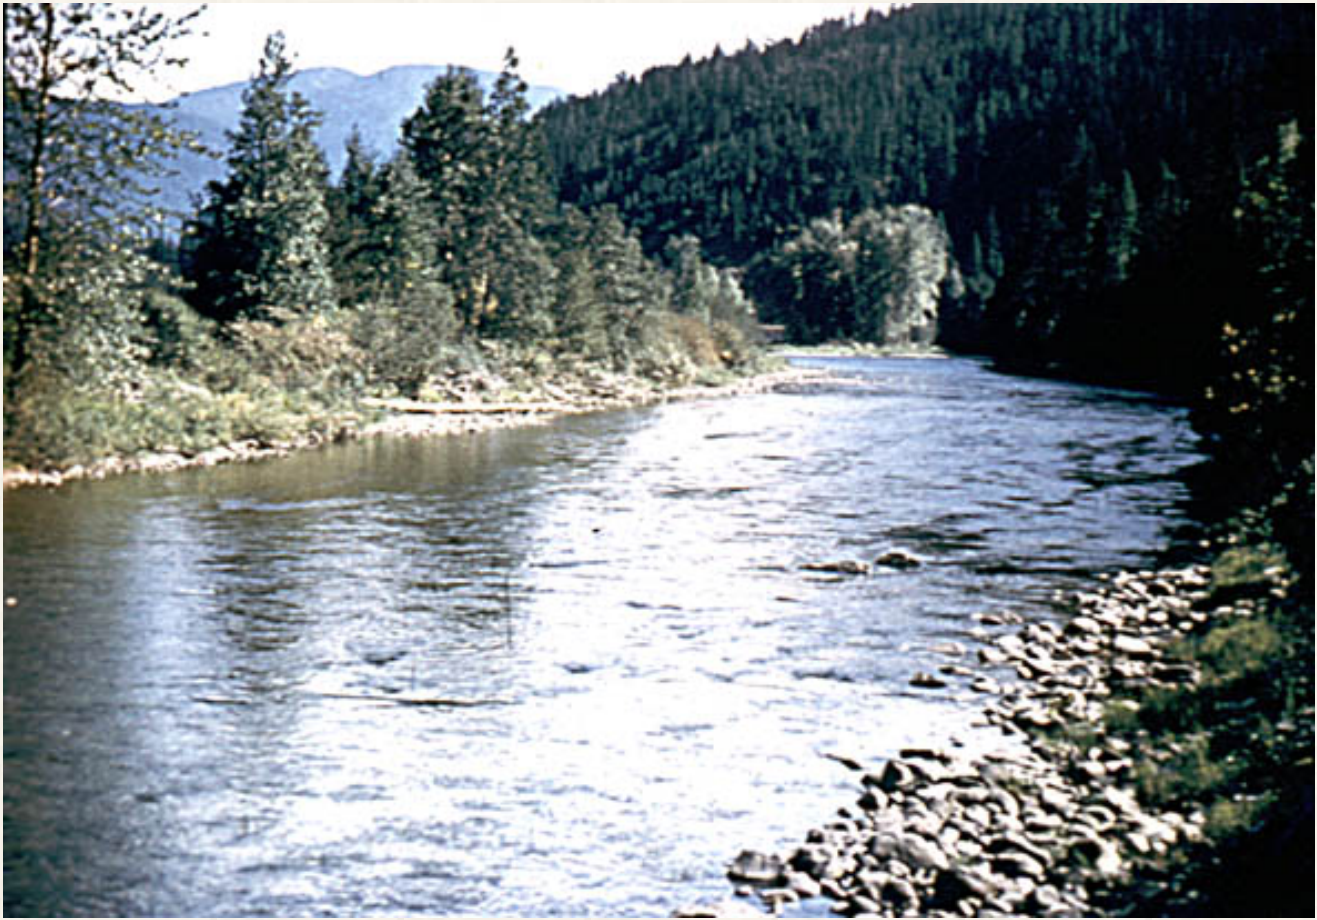
Photo 123: Downstream from right bank above section 2, Moyie River at Eastport, Idaho .

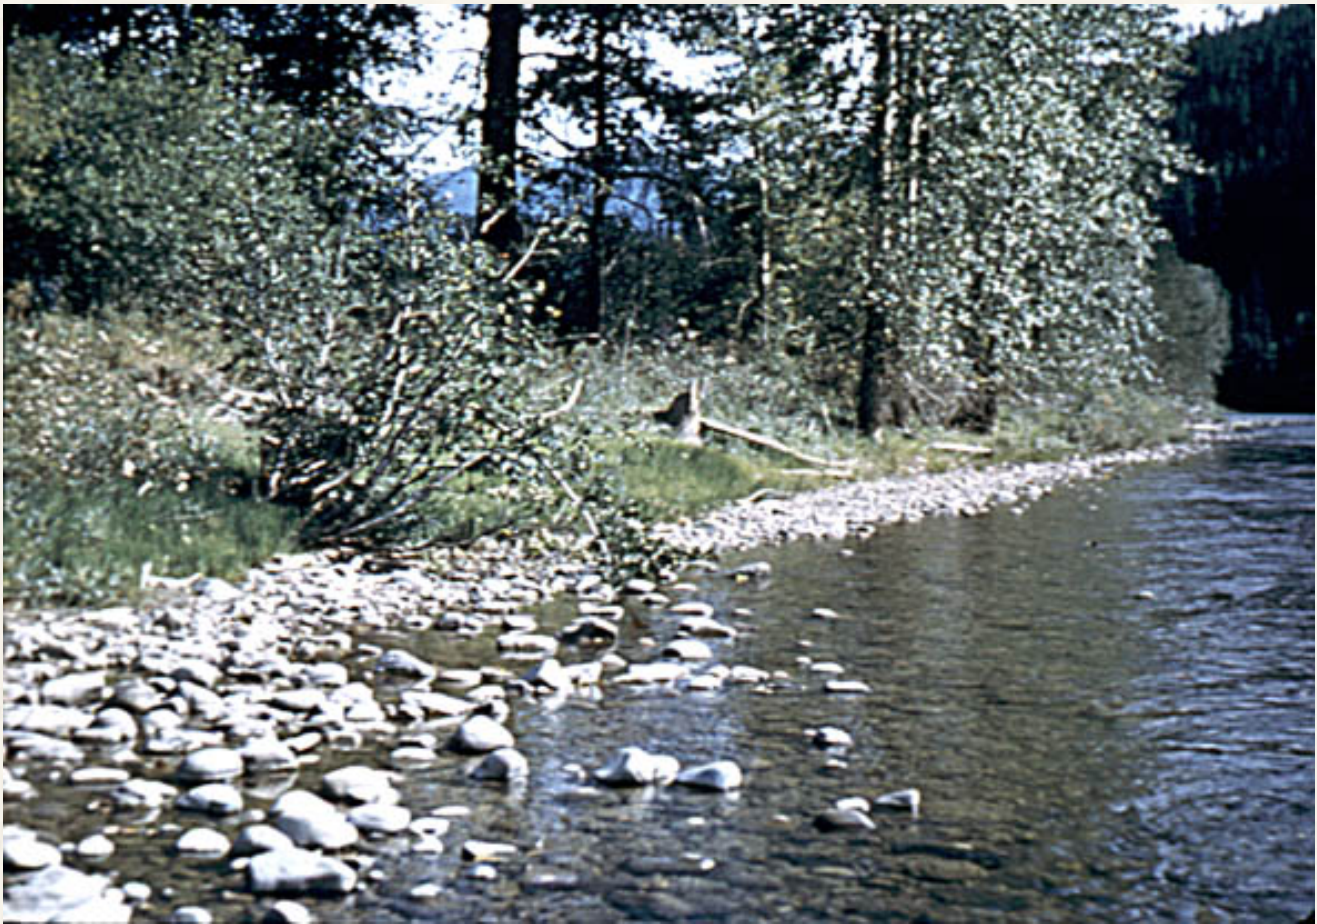
Photo 126: Downstream along left bank at section 3, Moyie River at Eastport, Idaho .
