# SURFACE-WATER FIELD TECHNIQUES

## Verified Roughness Characteristics of Natural Channels

Most hydraulic computations related to indirect estimates of discharge require an evaluation of the roughness characteristics of the channel. In the absence of a satisfactory quantitative procedure this evaluation remains chiefly an art. The ability to evaluate roughness coefficients must be developed through experience. One means of gaining this experience is by examining and becoming acquainted with the appearance of some typical channels whose roughness coefficients are known.

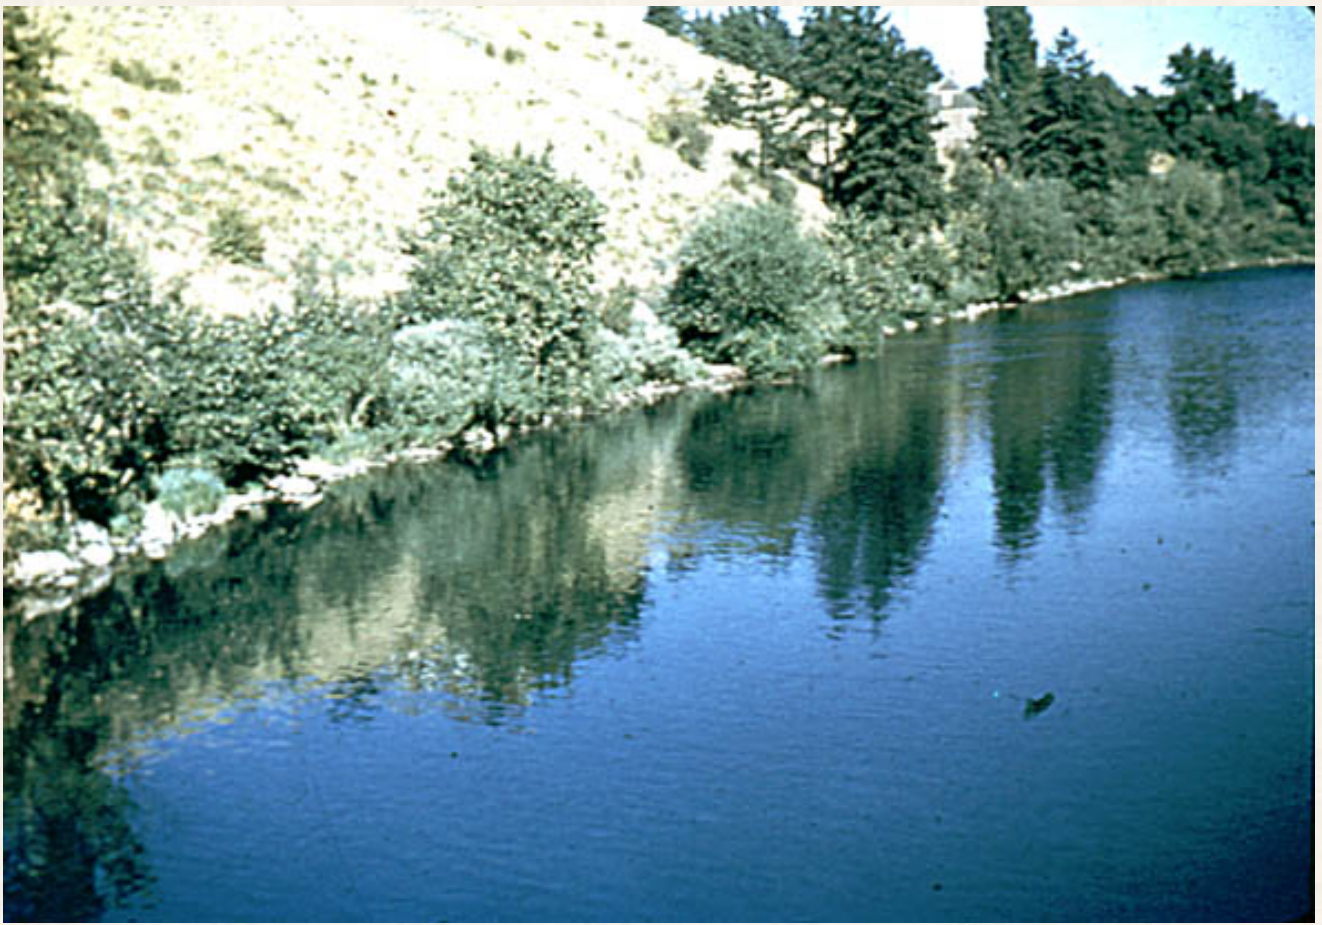
Photo 162: Upstream along right bank from section 4, Spokane River at Spokane, Washington.

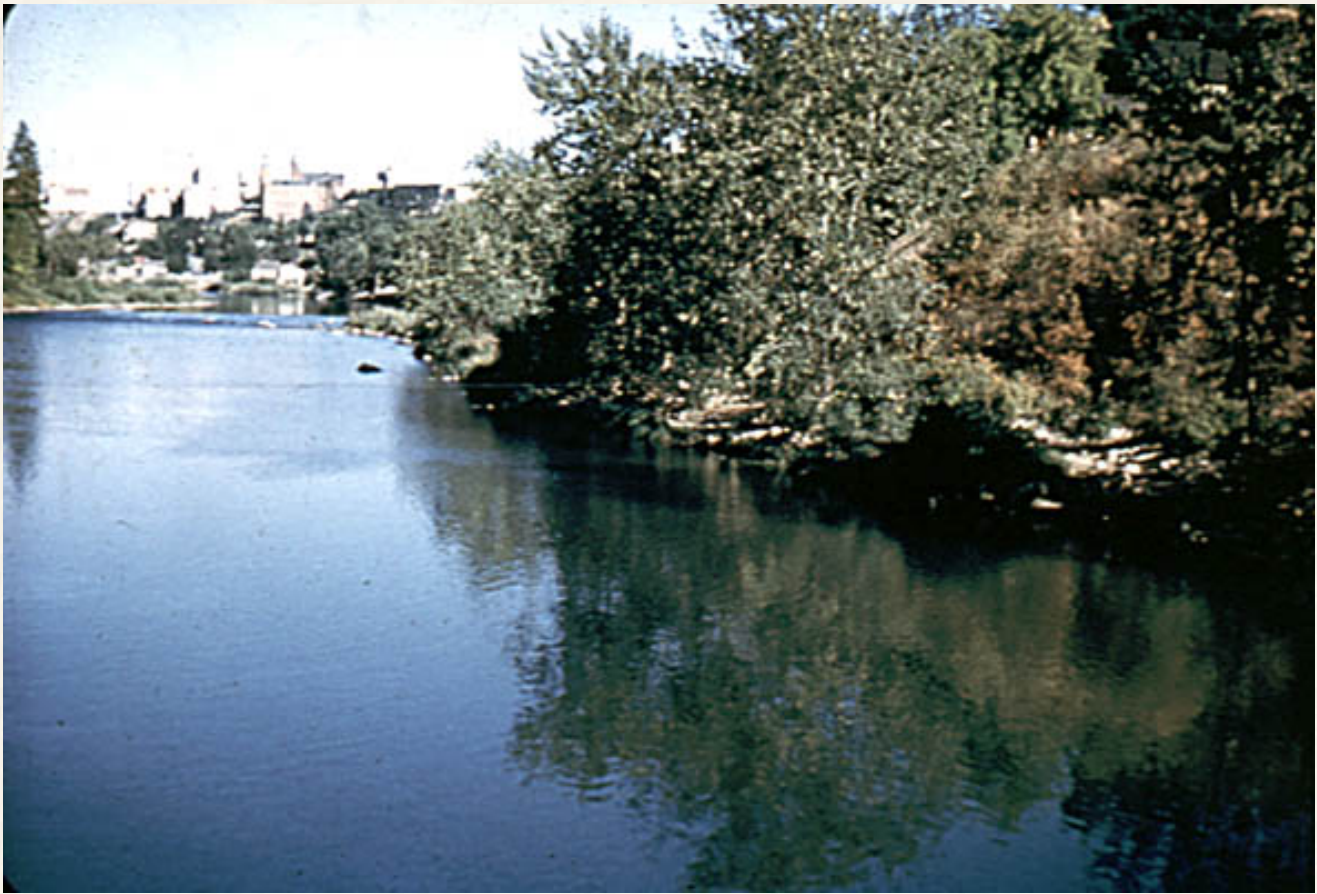
Photo 163: Upstream along left bank from section 4, Spokane River at Spokane, Washington.

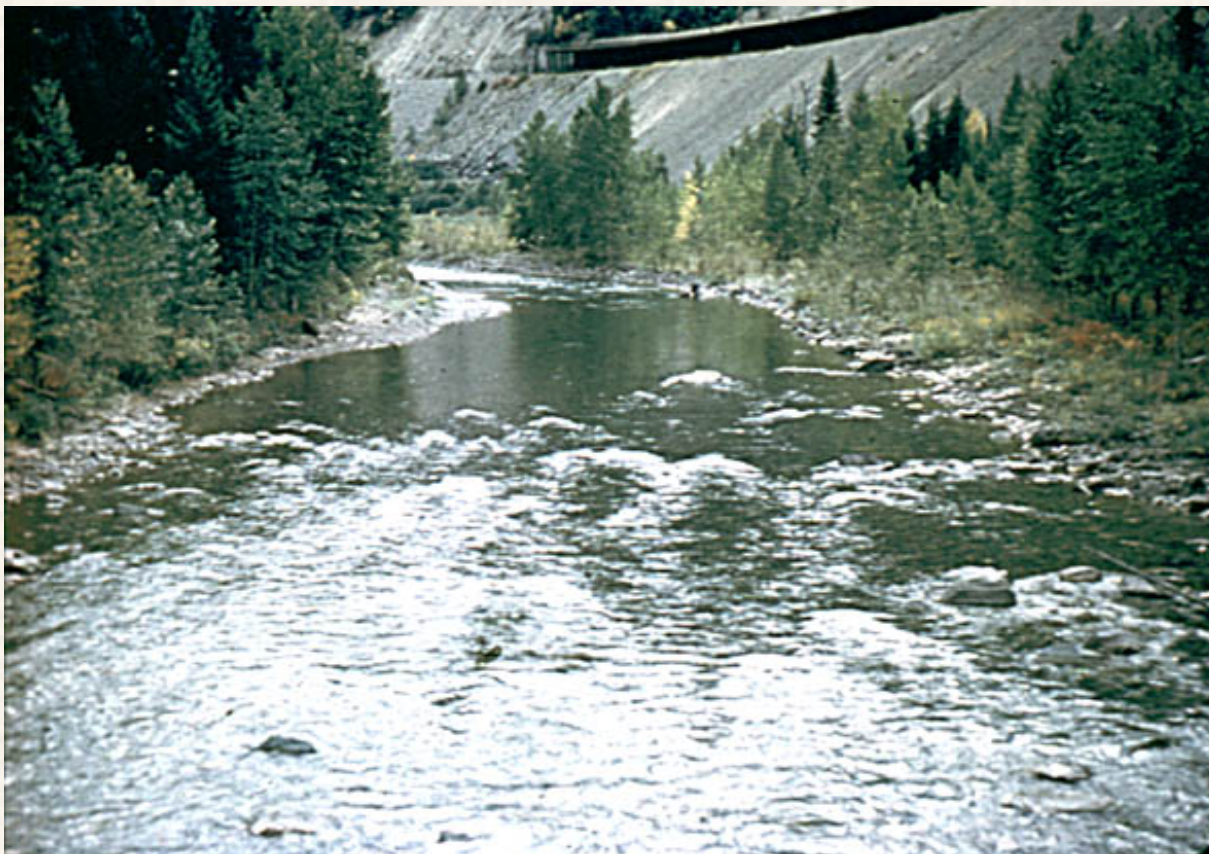
Photo 112: Upstream from section 4, Middle Fork Flathead River near Essex, Montana.

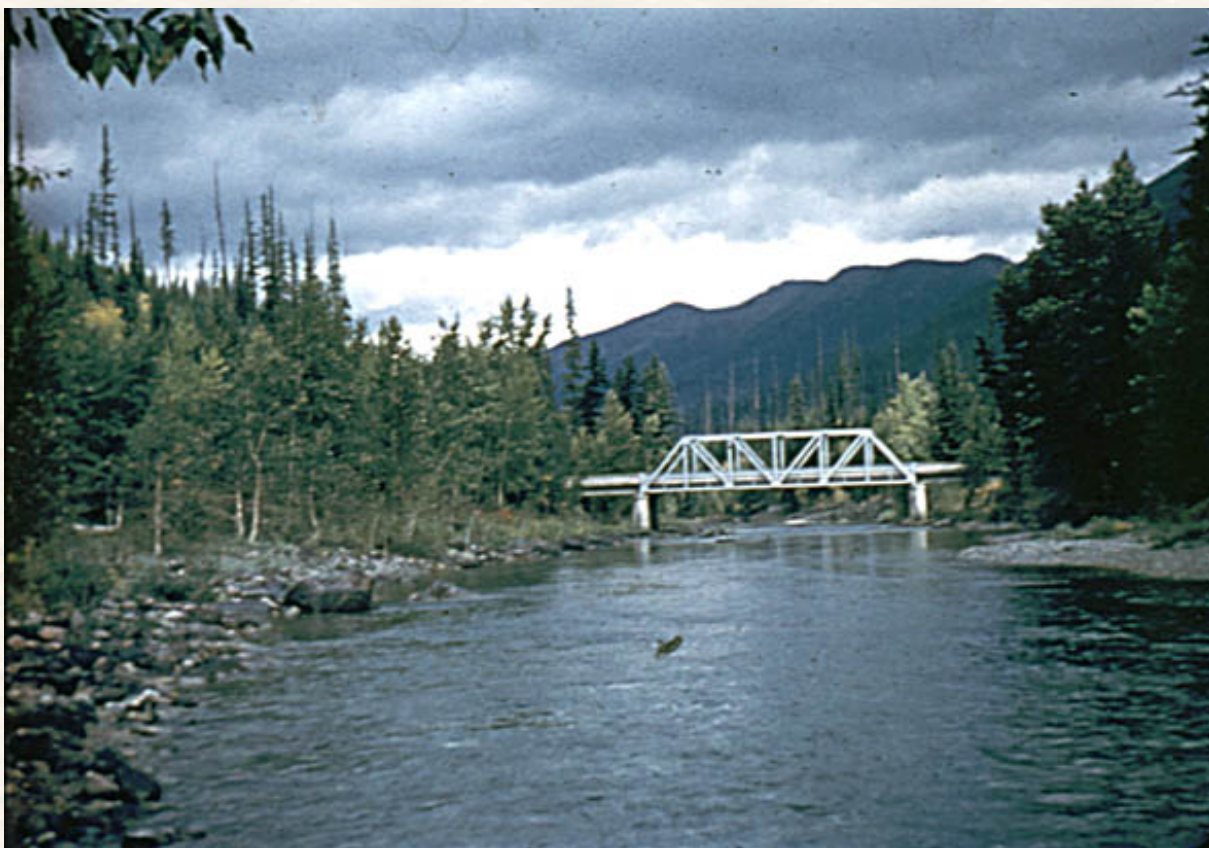
Photo 117: Downstream from section 1, Middle Fork Flathead River near Essex, Montana.

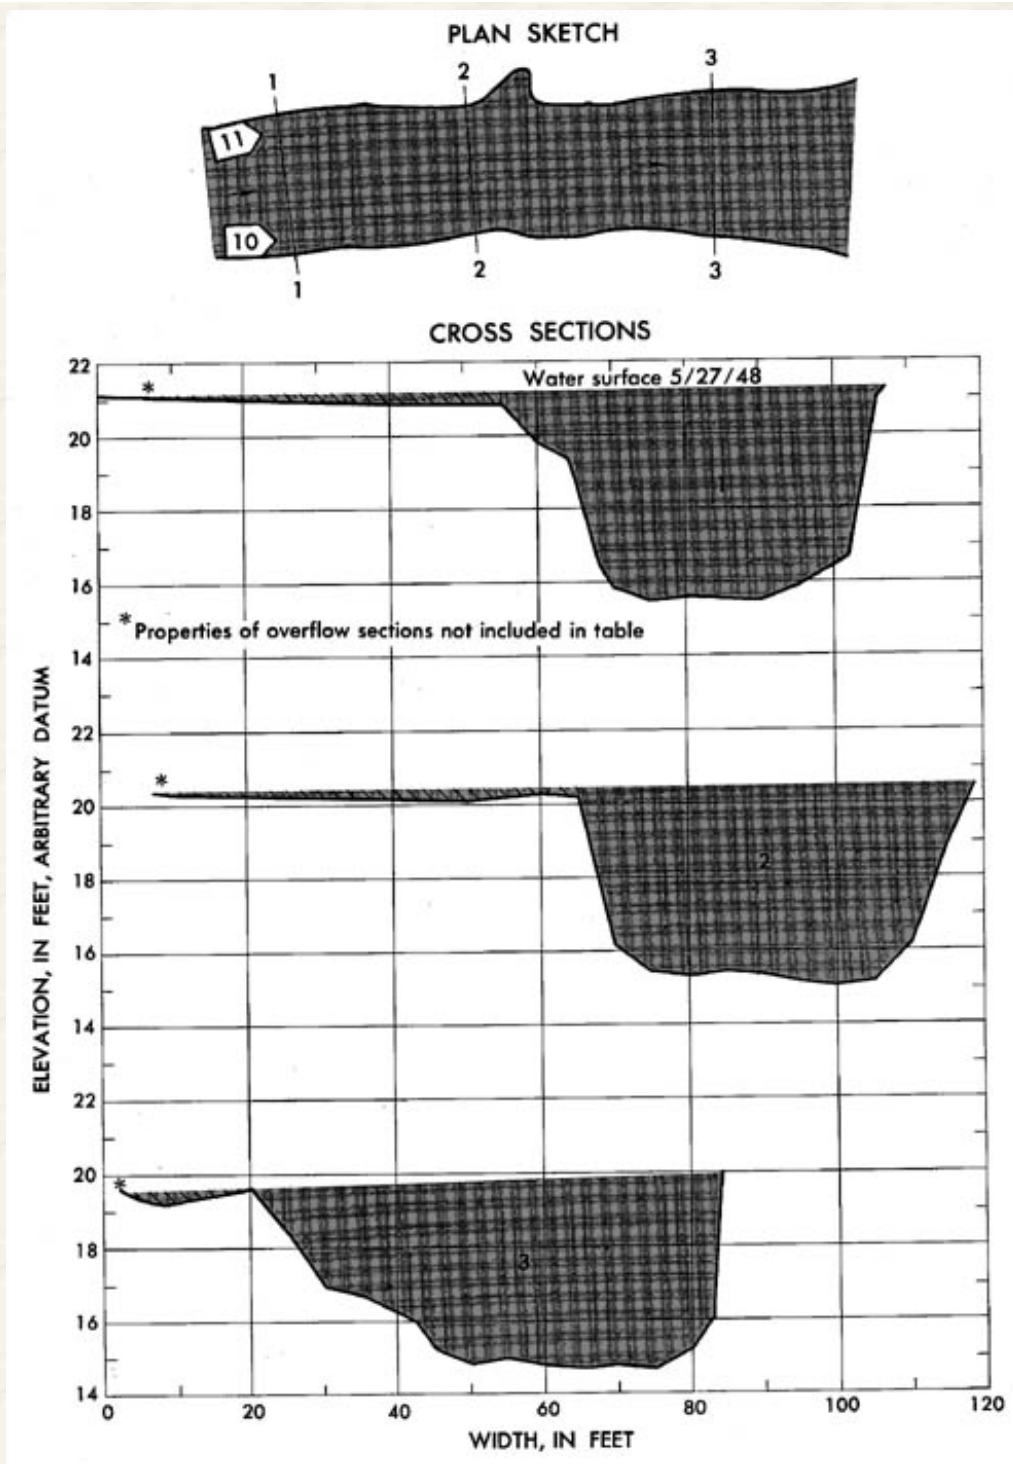
Plan sketch and crocc sections, Catherine Creek near Union, Oregon

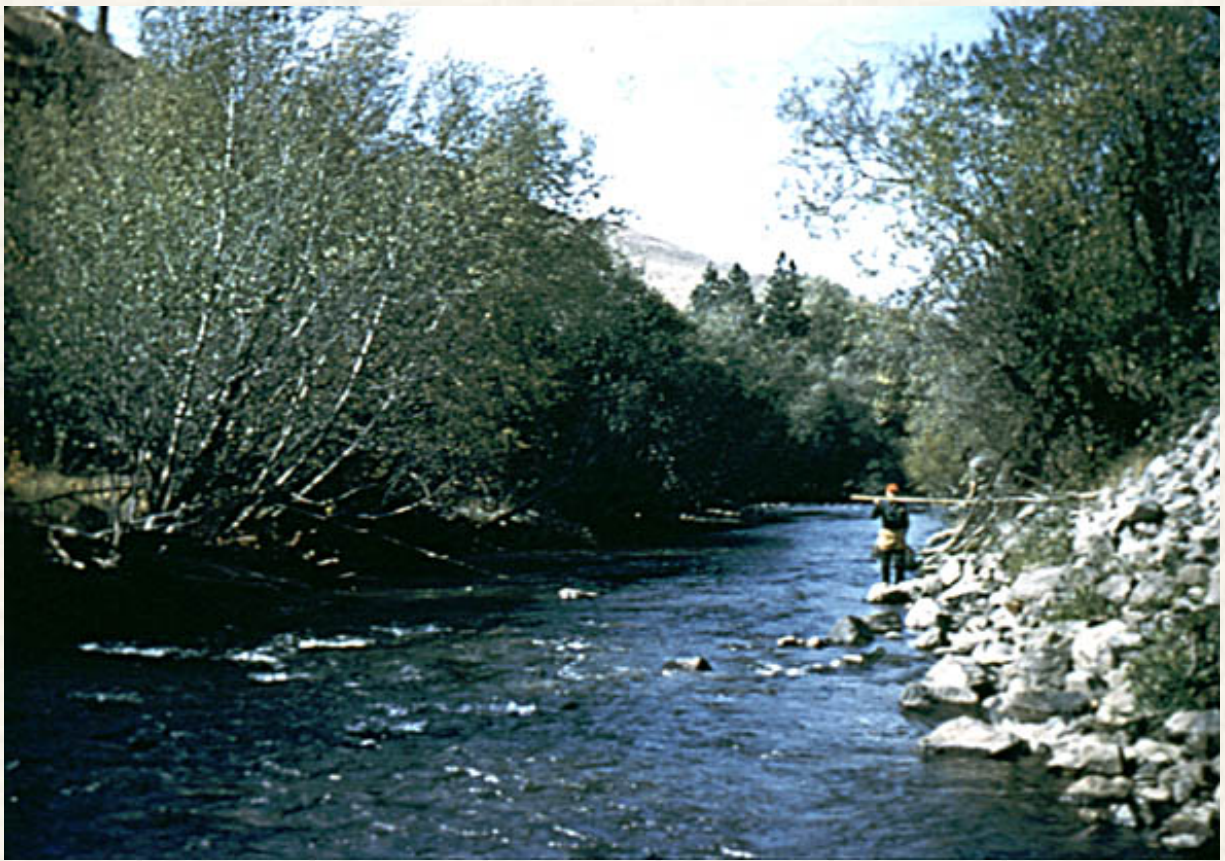
Photo 10: Downstream along right bank from above reach, Catherine Creek near Union, Oregon.

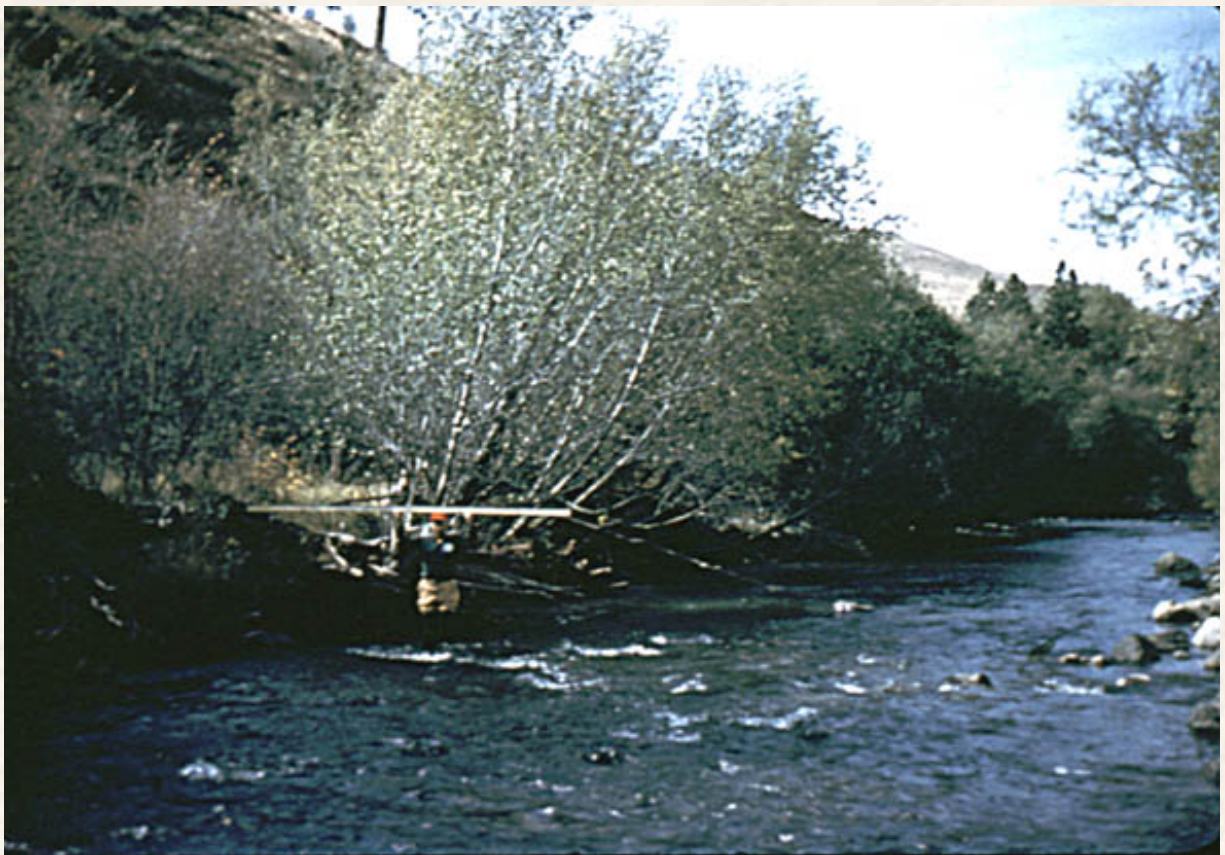
Photo 11: Downstream along left bank from above reach, Catherine Creek near Union, Oregon.

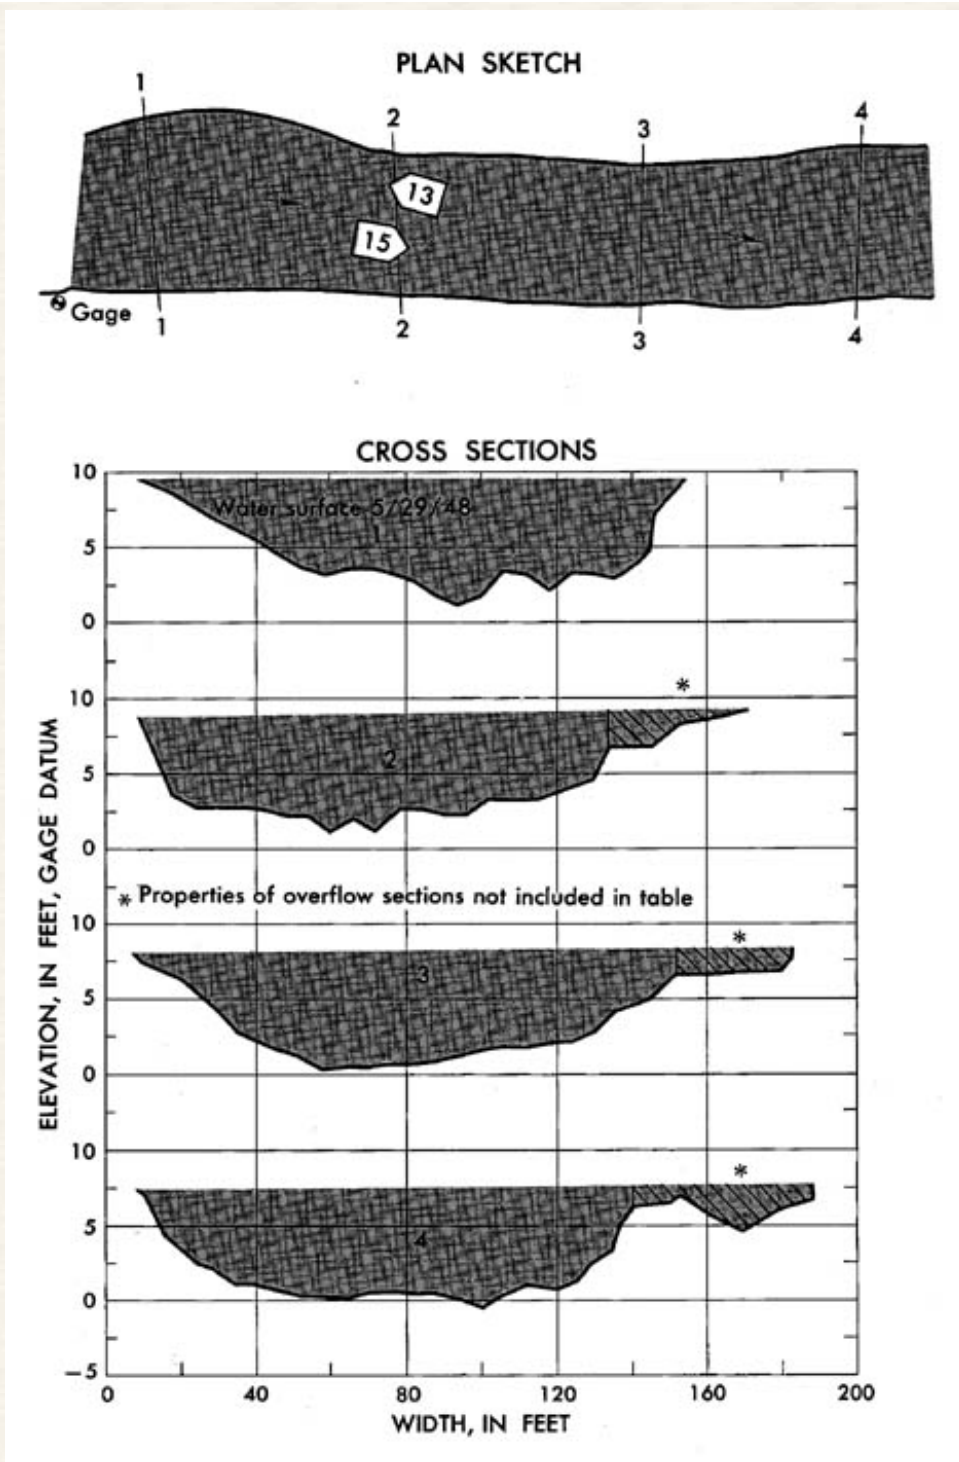
Plan sketch and cross sections, Chiwawa River near Plain, Washington.

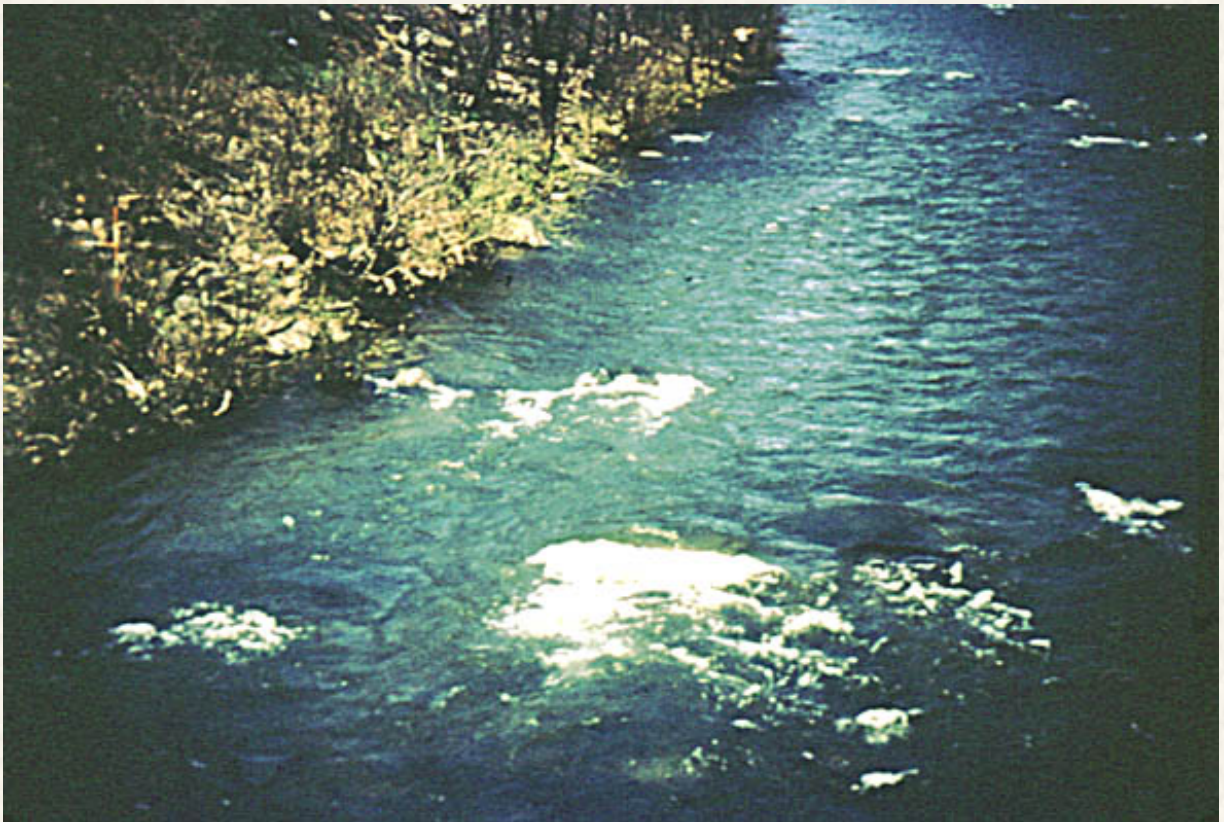
Photo 13: Upstream along left bank from section 2, Chiwawa River near plain, Washington.

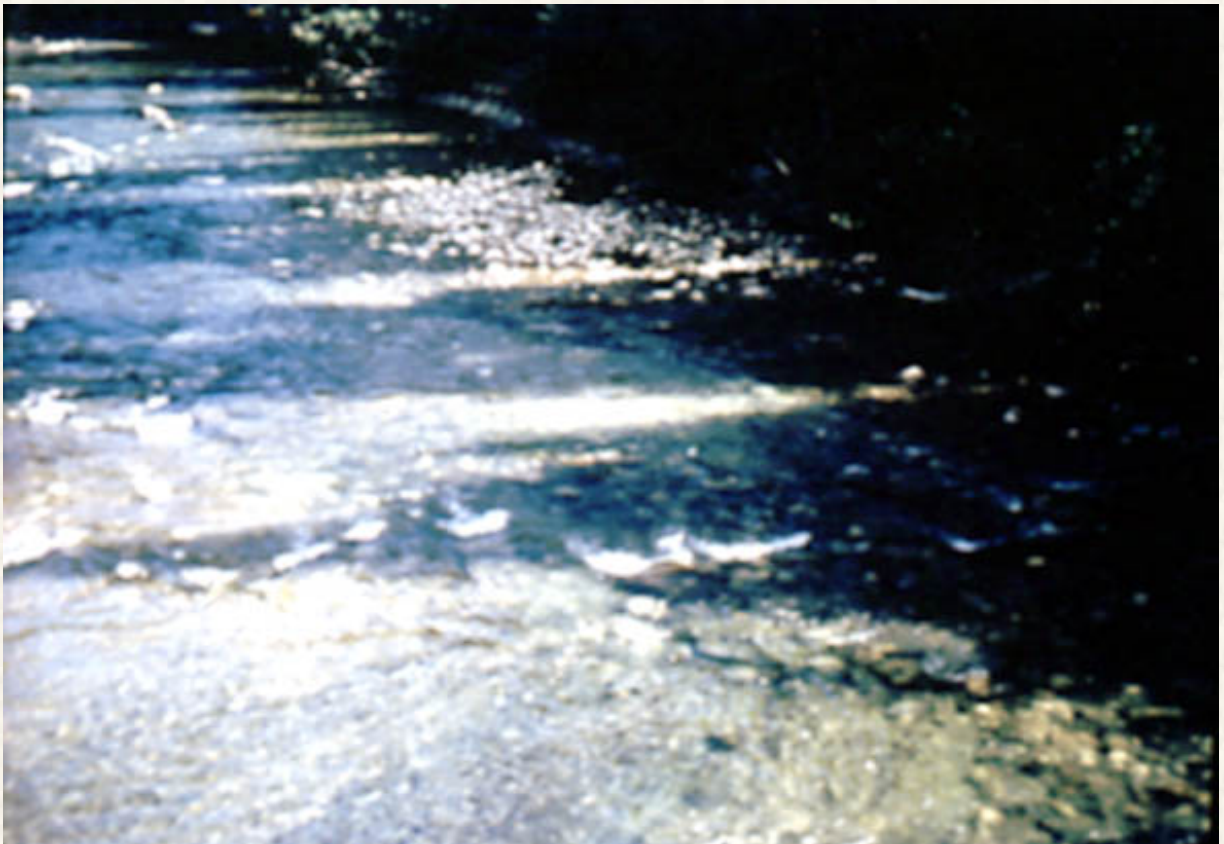
Photo 15: Downstream along right bank from section 2, Chiwawa River near plain, Washington.

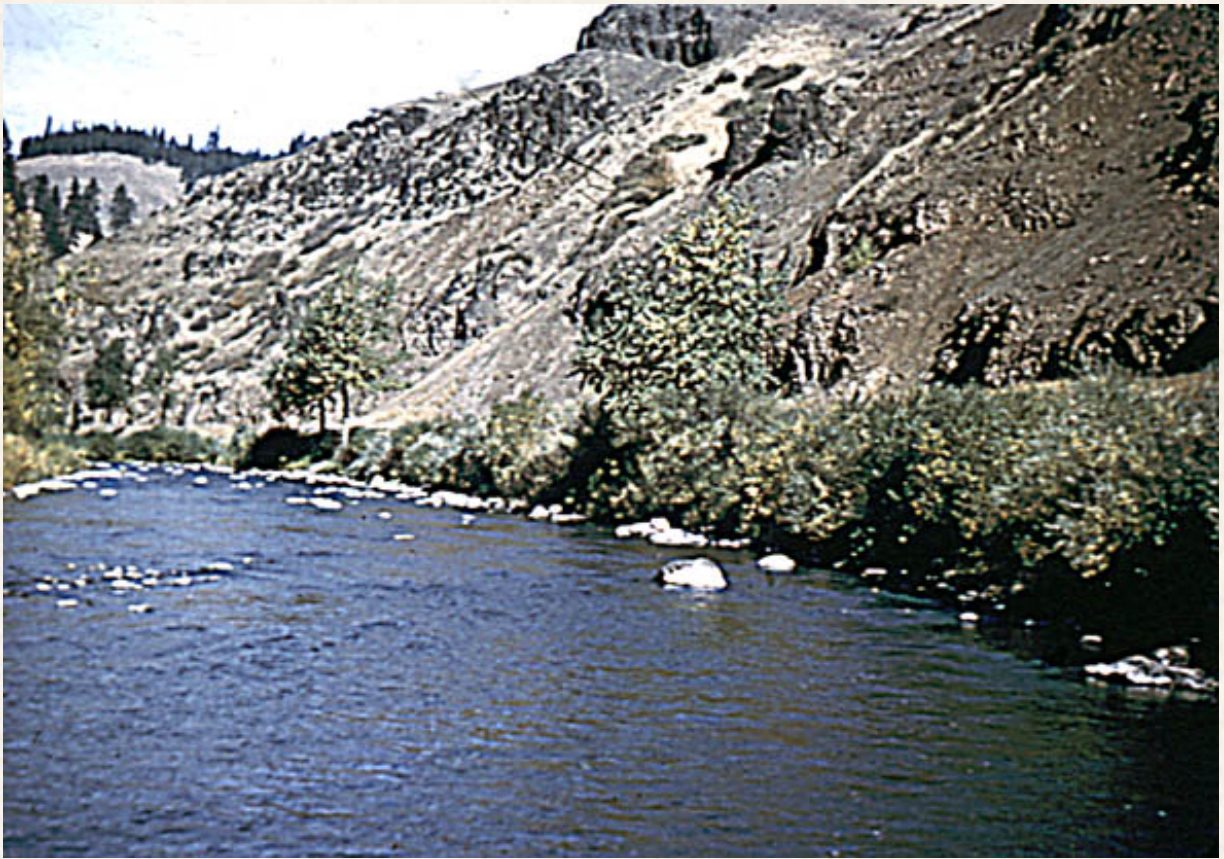
Photo 13: Upstream along left bank from channel below section 3, Grande Ronde River at La Gande, Oregon

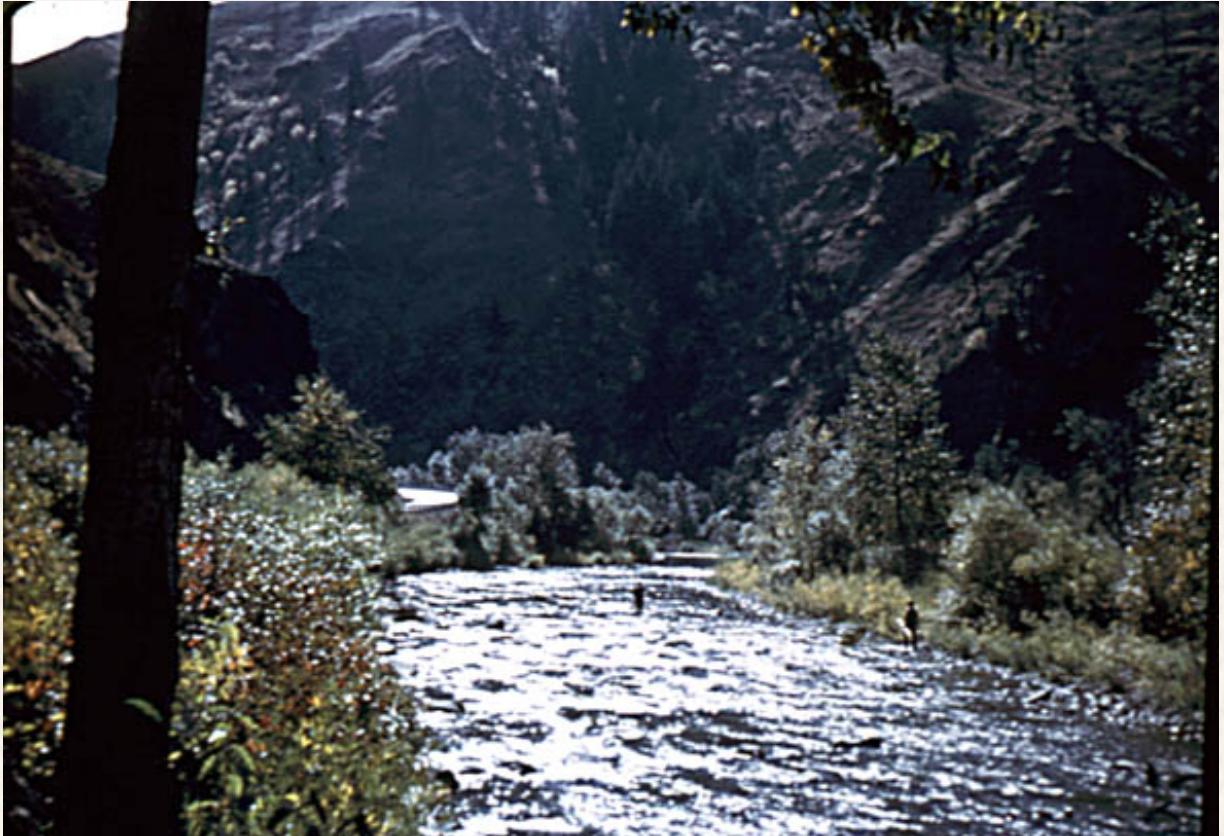
Photo 15: Downstream from left bank above section 1, Grande Ronde River at La Gande, Oregon

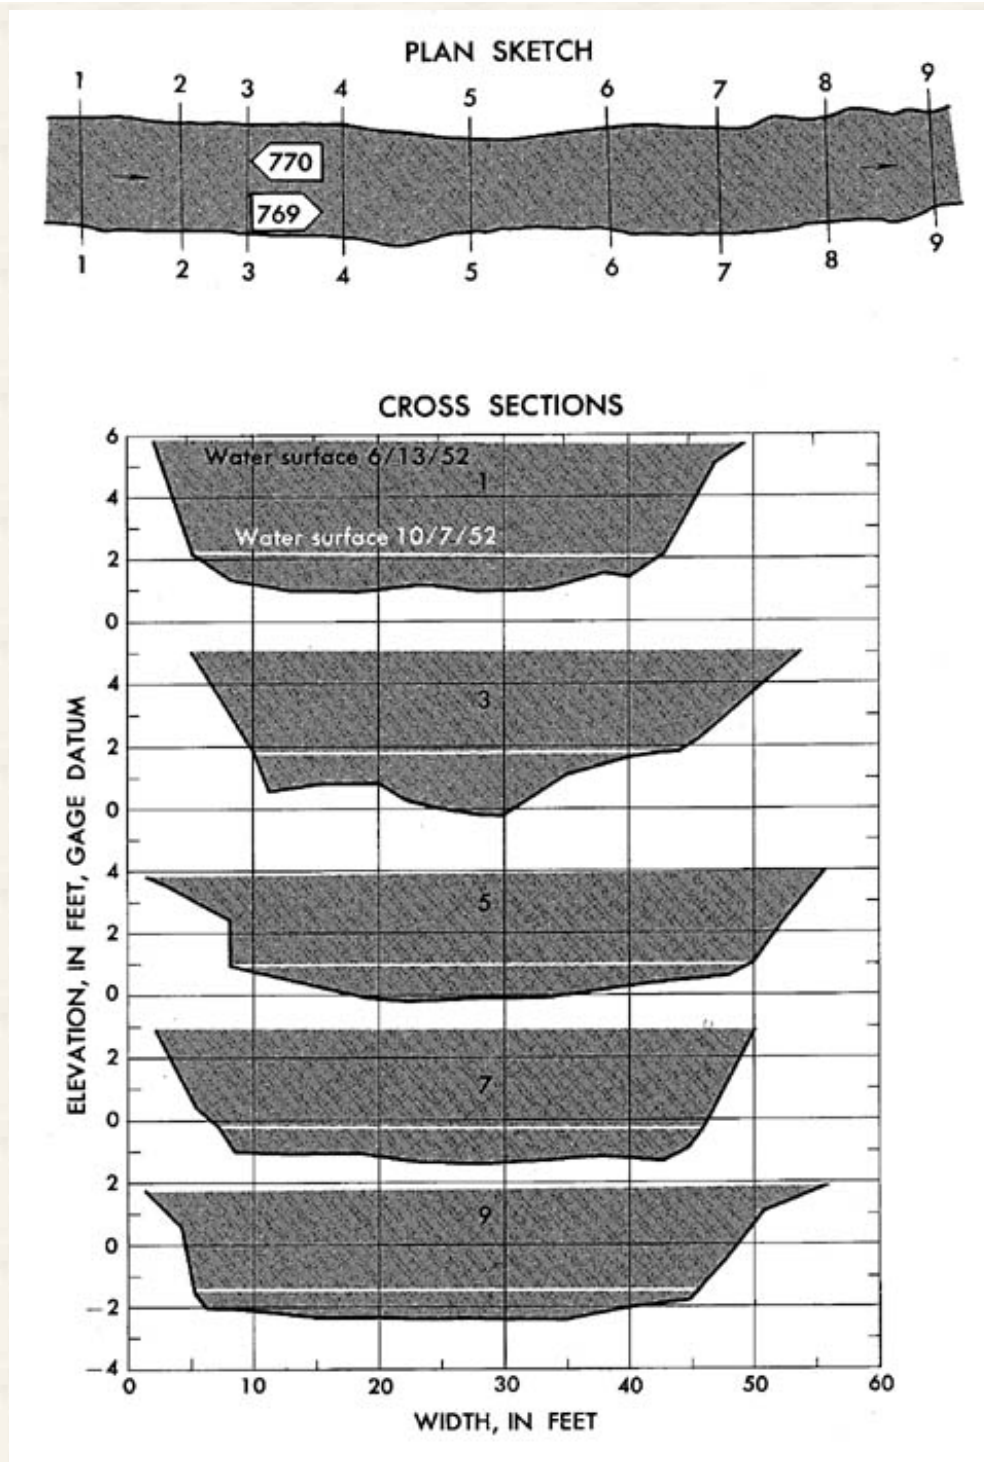
Plan sketch and cross sections, Provo River near Hailstone, Utah.

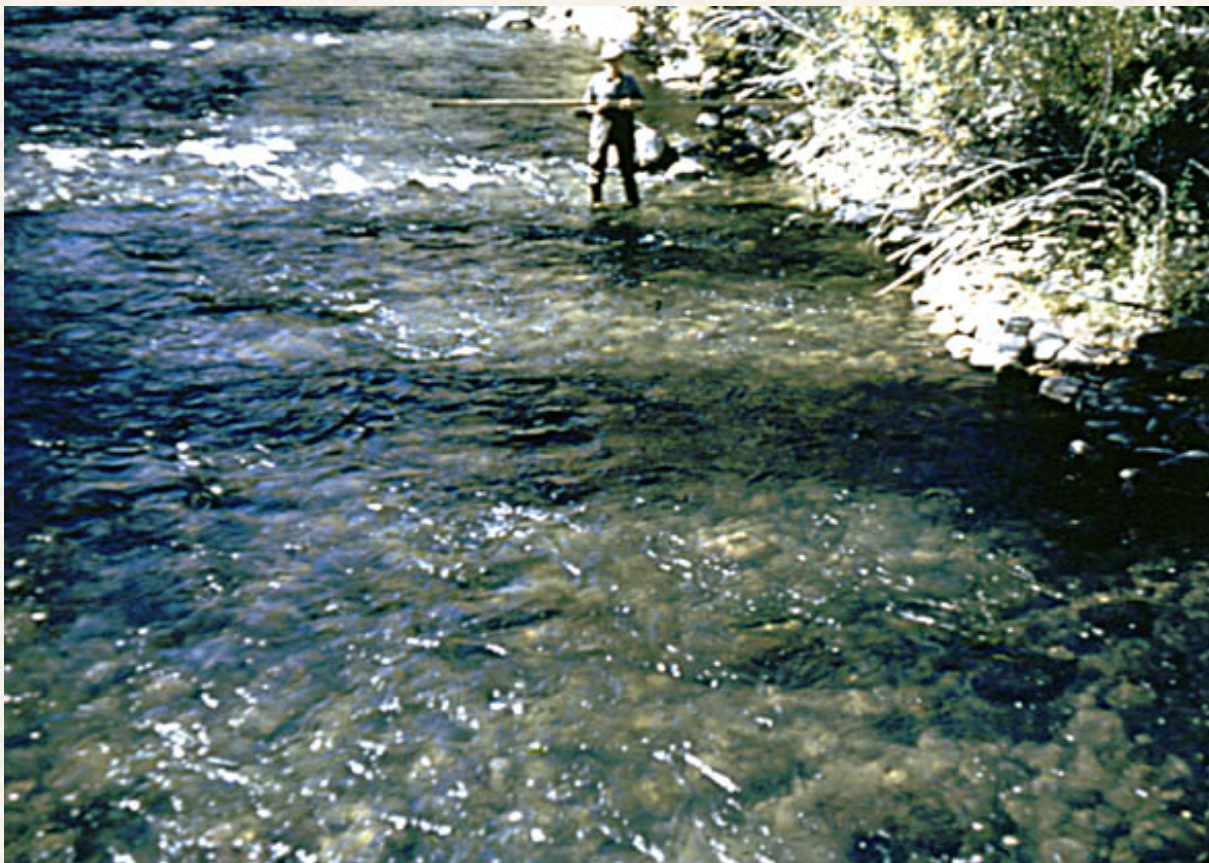
Photo 13: Downstream from section 3, Provo River near Hailstone, Utah.

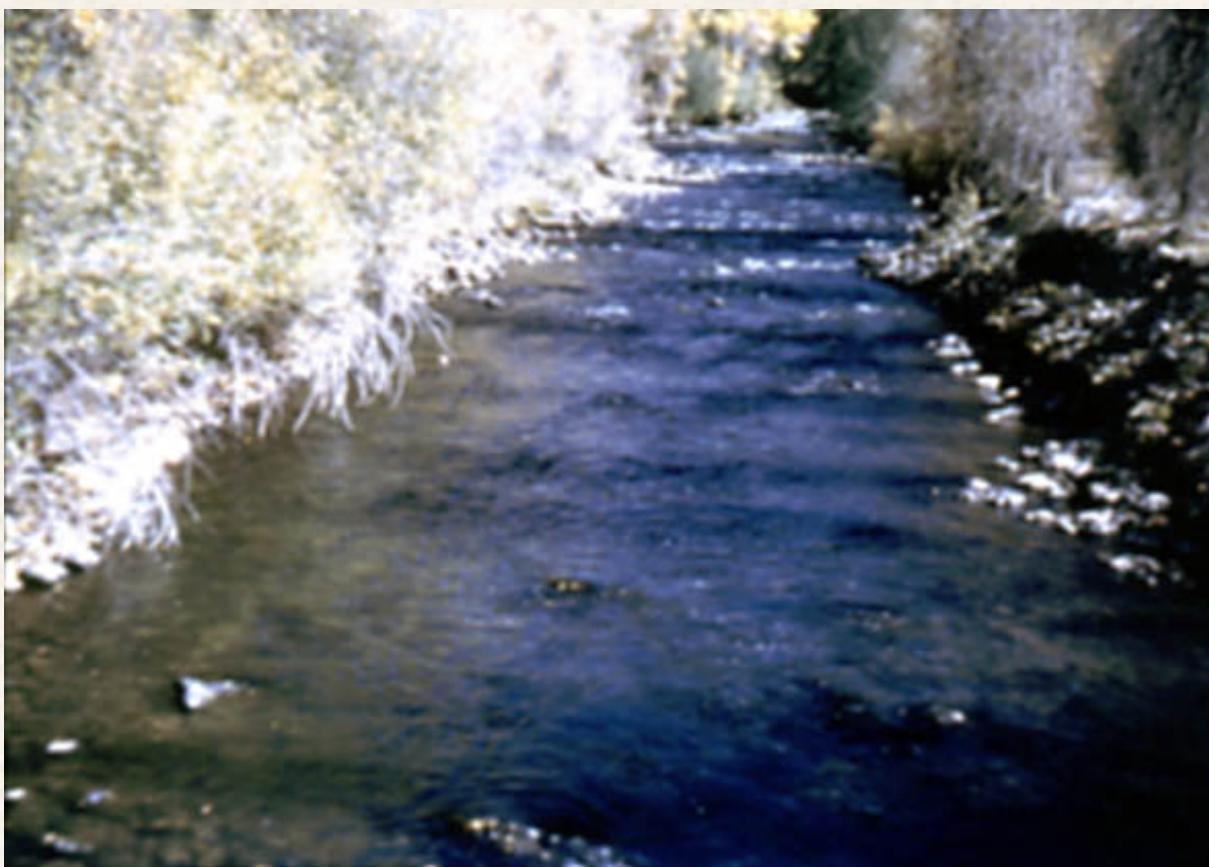
Photo 15: Upstream from section 3, Provo River near Hailstone, Utah.

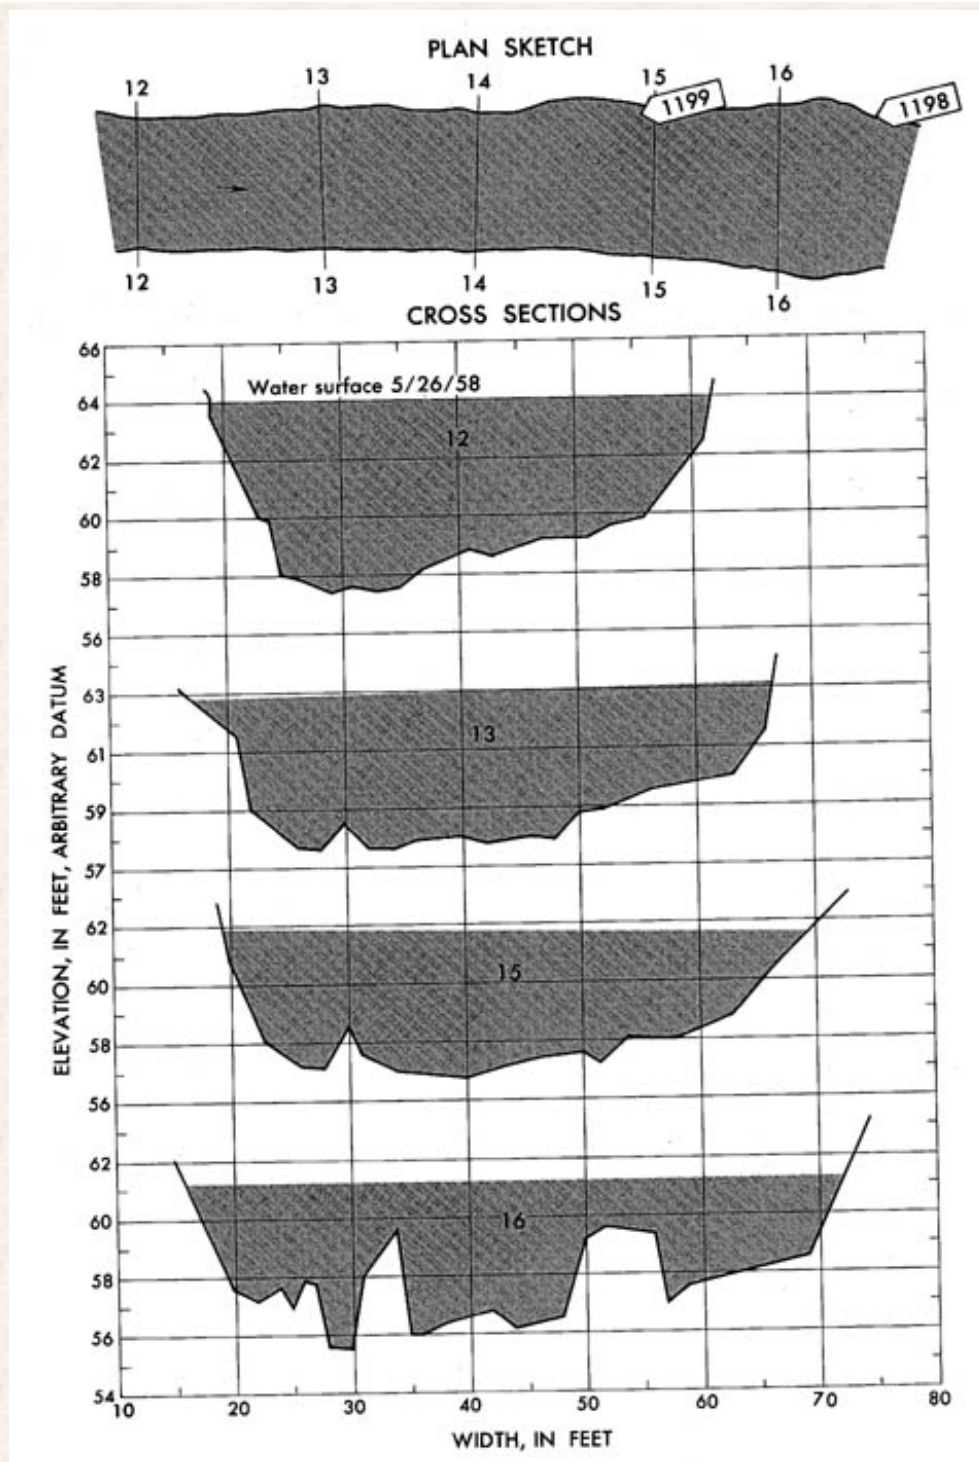
Plan sketch and cross sections, Clear Creek near Golden, Colorado

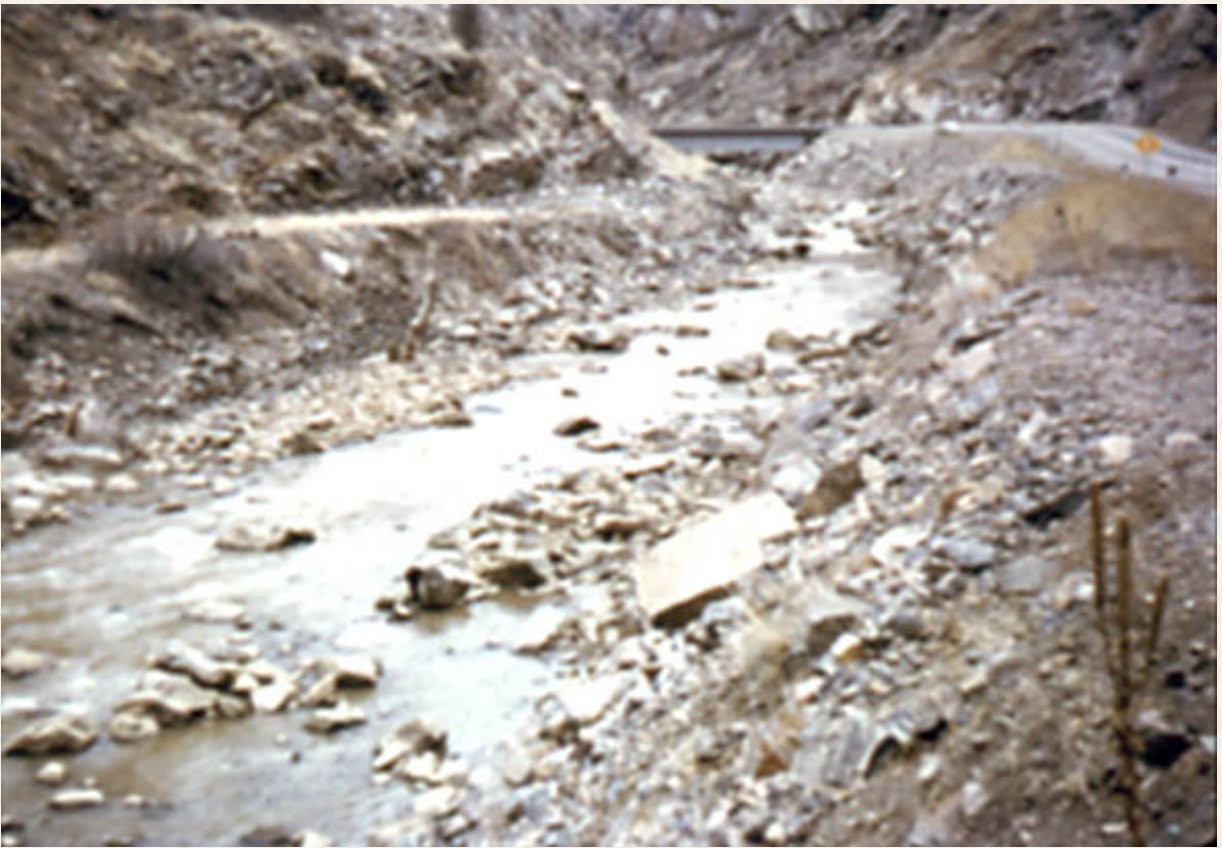
Photo 1198: Upstream from section 16, Clear Creek near Golden, Colorado.

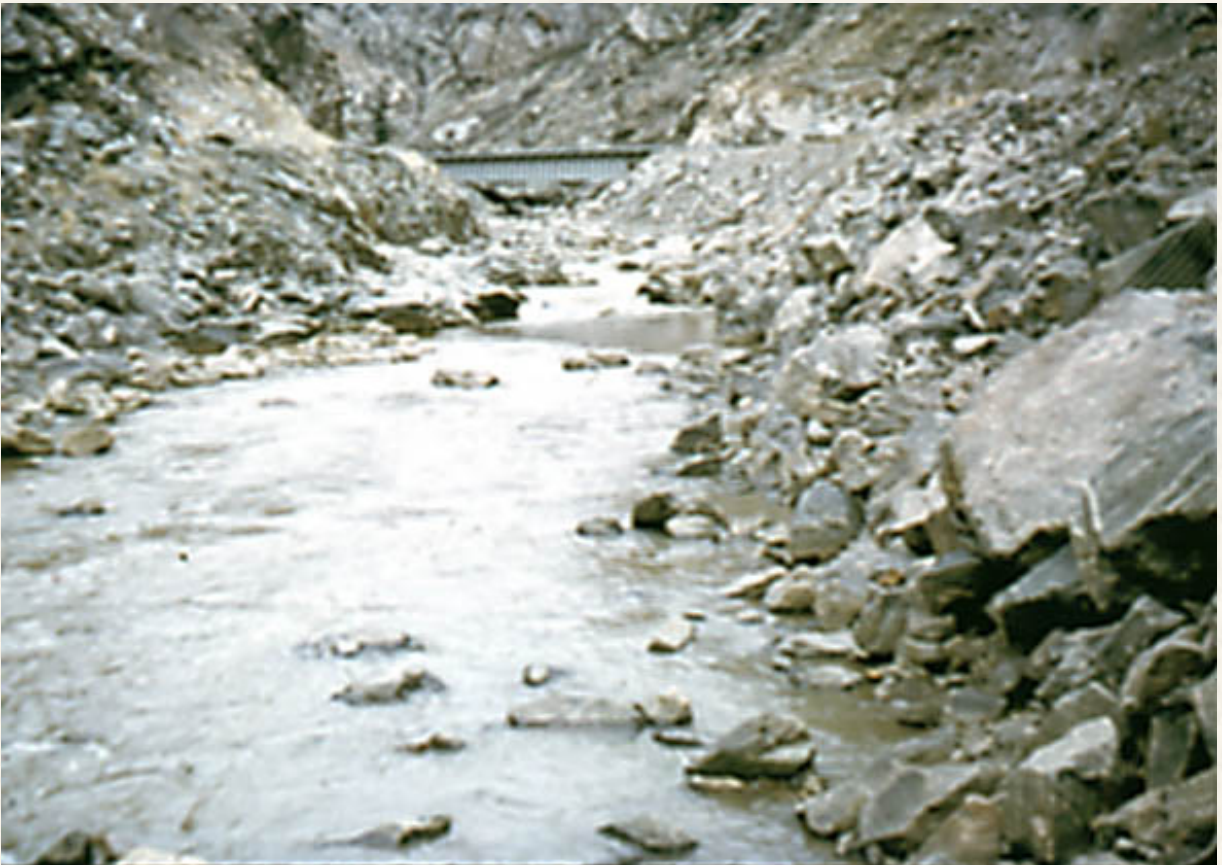
Photo 1199: Downstream from left bank at section 15, Clear Creek near Golden, Colorado

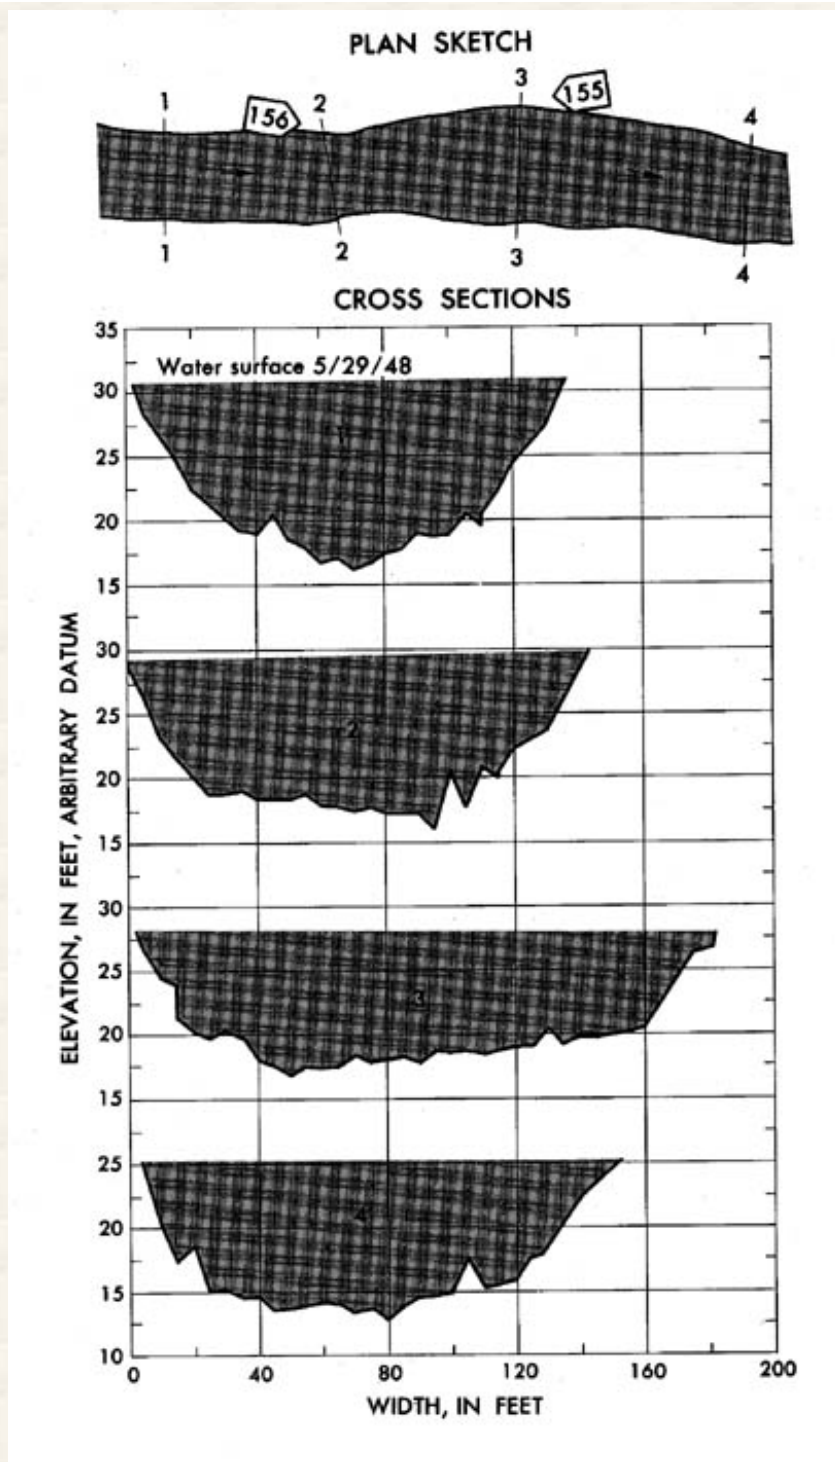
Plan and cross sections, South Fork Clearwater River near Grangeville, Idaho.
