# SURFACE-WATER FIELD TECHNIQUES

## Verified Roughness Characteristics of Natural Channels

Most hydraulic computations related to indirect estimates of discharge require an evaluation of the roughness characteristics of the channel. In the absence of a satisfactory quantitative procedure this evaluation remains chiefly an art. The ability to evaluate roughness coefficients must be developed through experience. One means of gaining this experience is by examining and becoming acquainted with the appearance of some typical channels whose roughness coefficients are known.

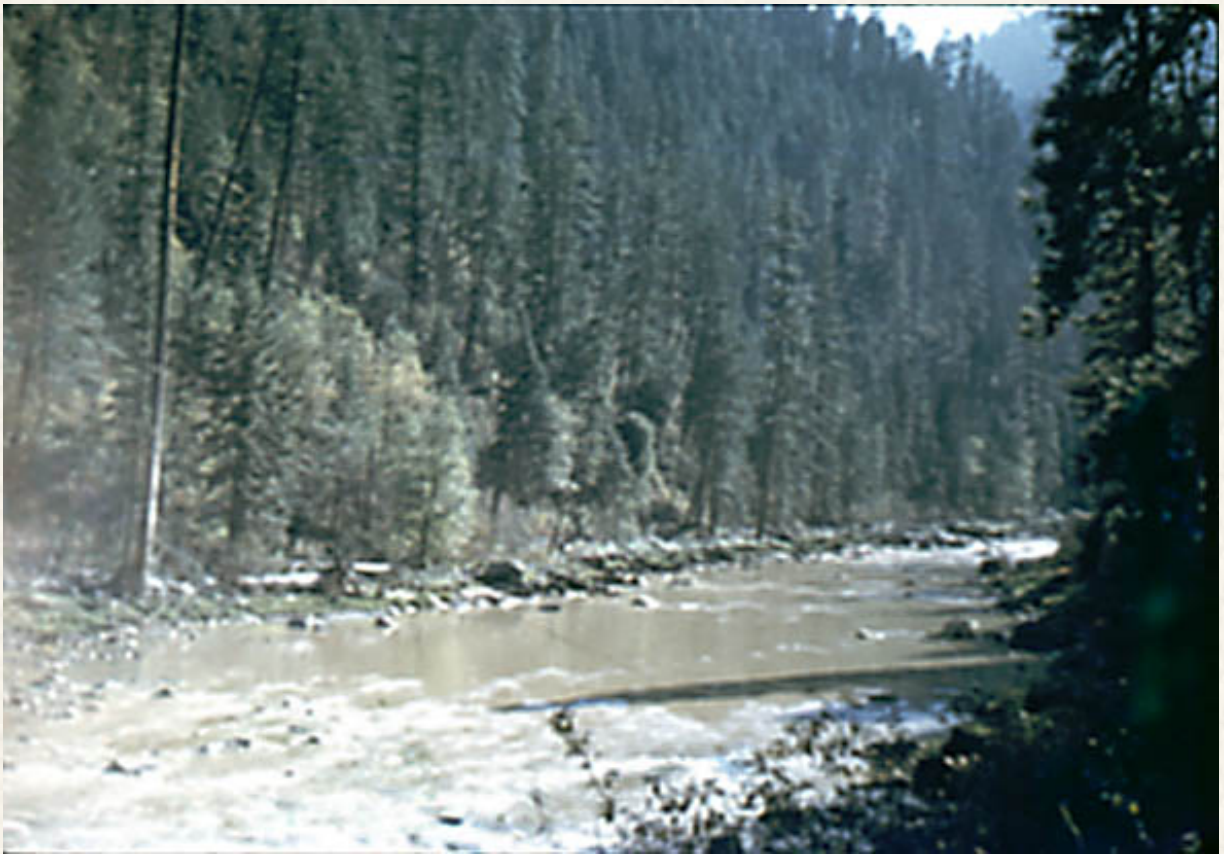
Photo 155: Upstream from left bank at section 3, South Fork Clearwater River near Grangeville, Idaho.

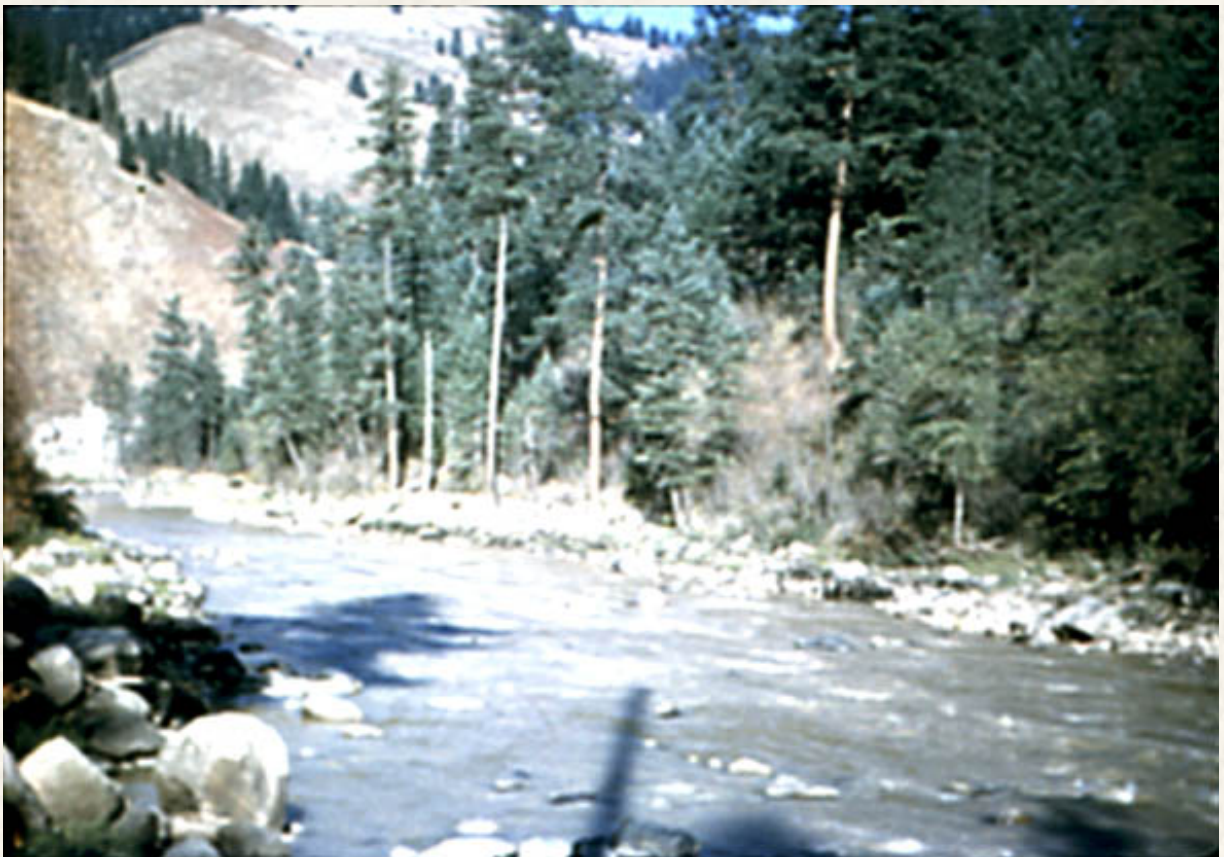
Photo 156: Downstream from left bank at section 2, South Fork Clearwater River near Grangeville, Idaho.

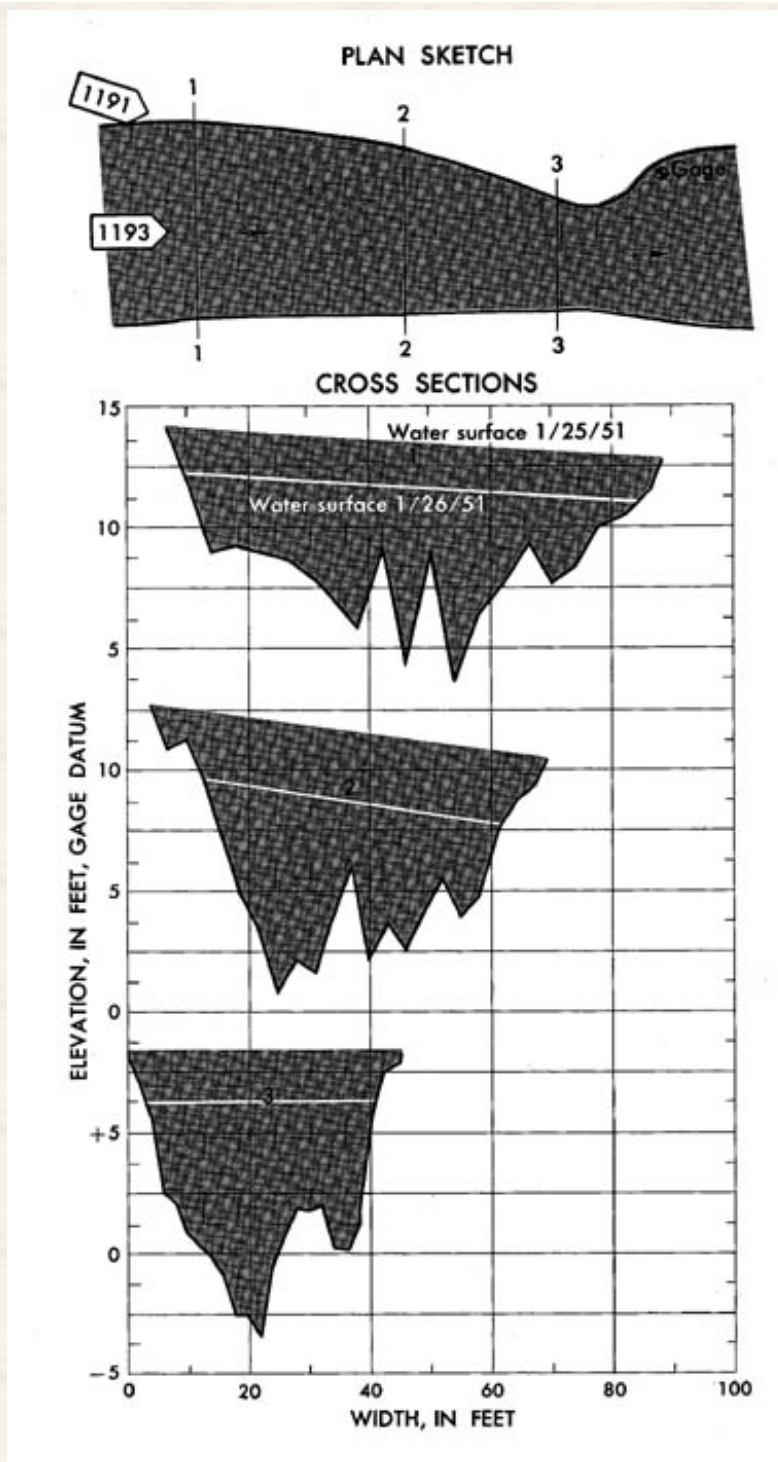
Plan and cross sections, Cache Creek near Lower Lake, California.

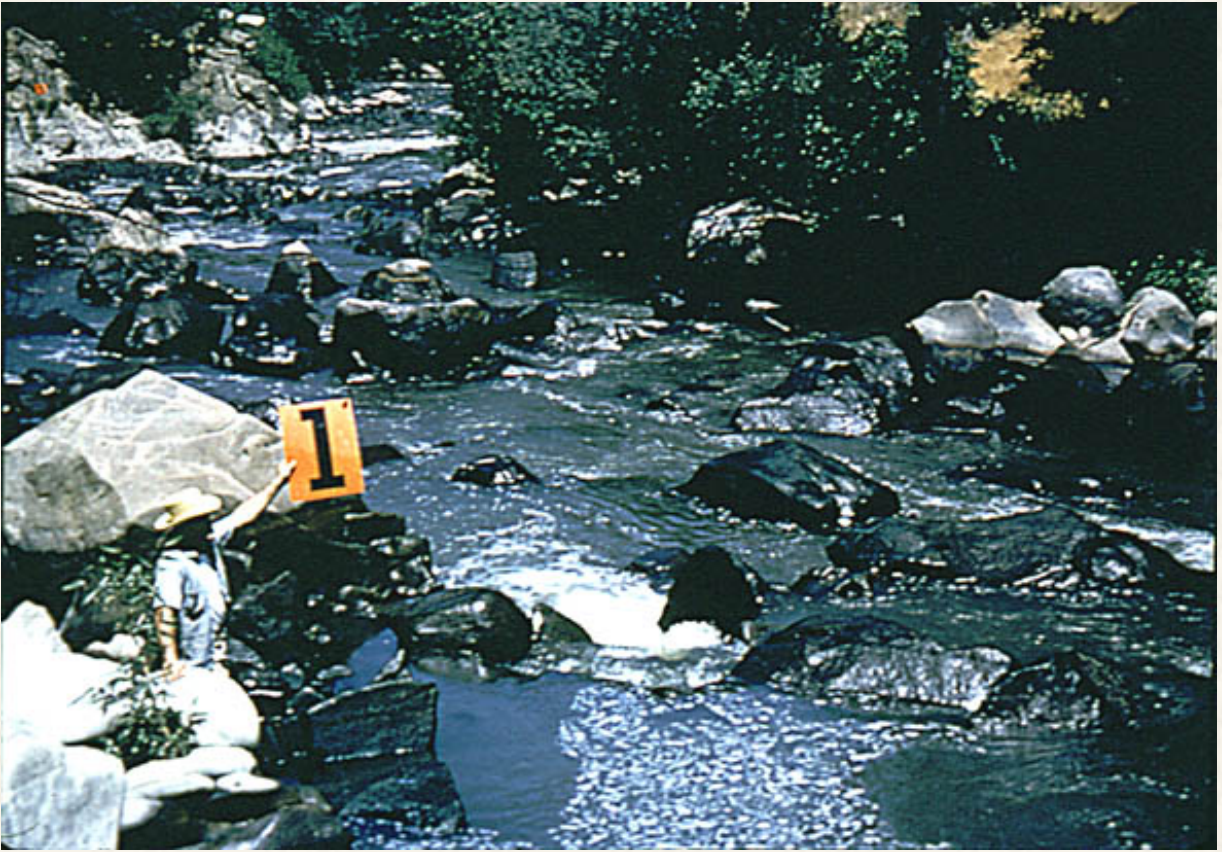
Photo 1191: Downstream from left bank above section 1, Cache Creek near Lower Lake, California.

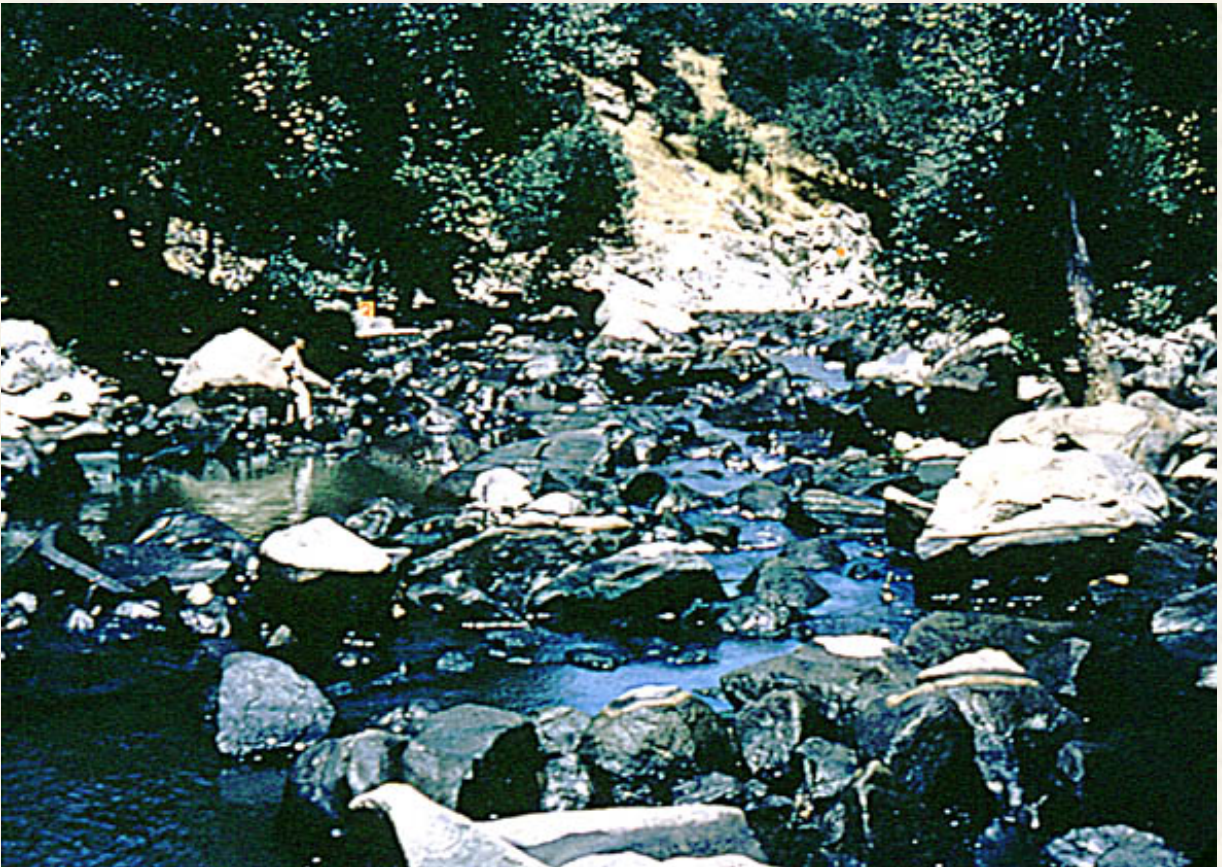
Photo 1193: Downstream from channel at section 1, Cache Creek near Lower Lake, California.

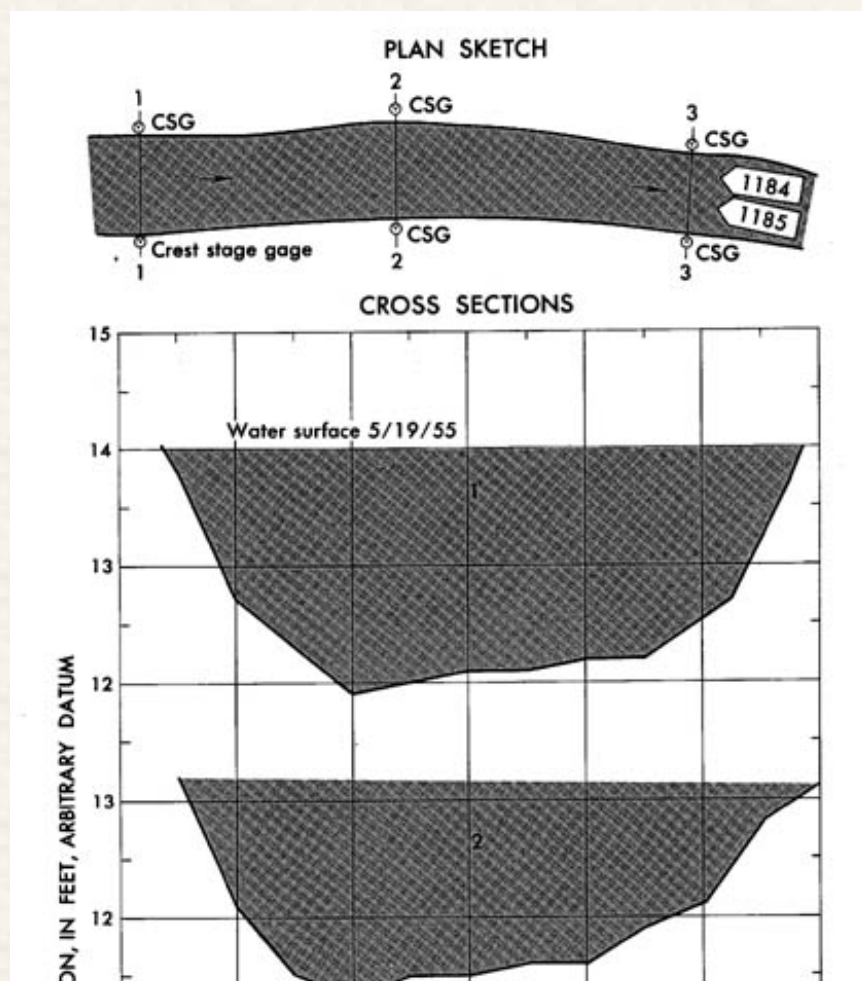
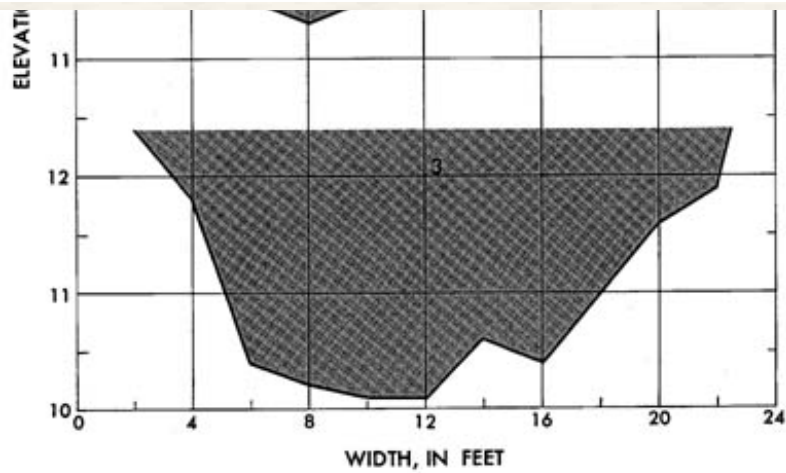
Plan and cross sections, Mission Creek near Cashmere, Washington.

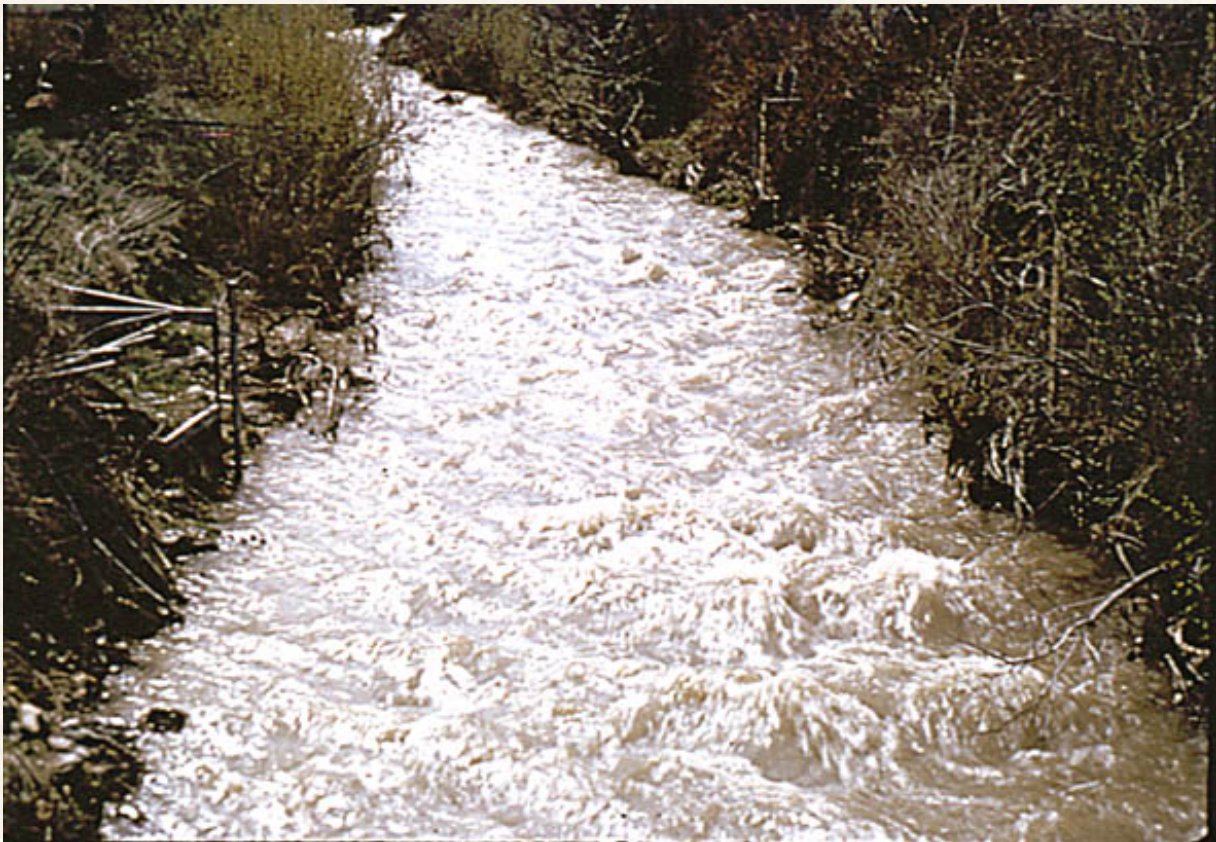
Photo 1184: Upstream from below section 3, Mission Creek near Cashmere, Washington.

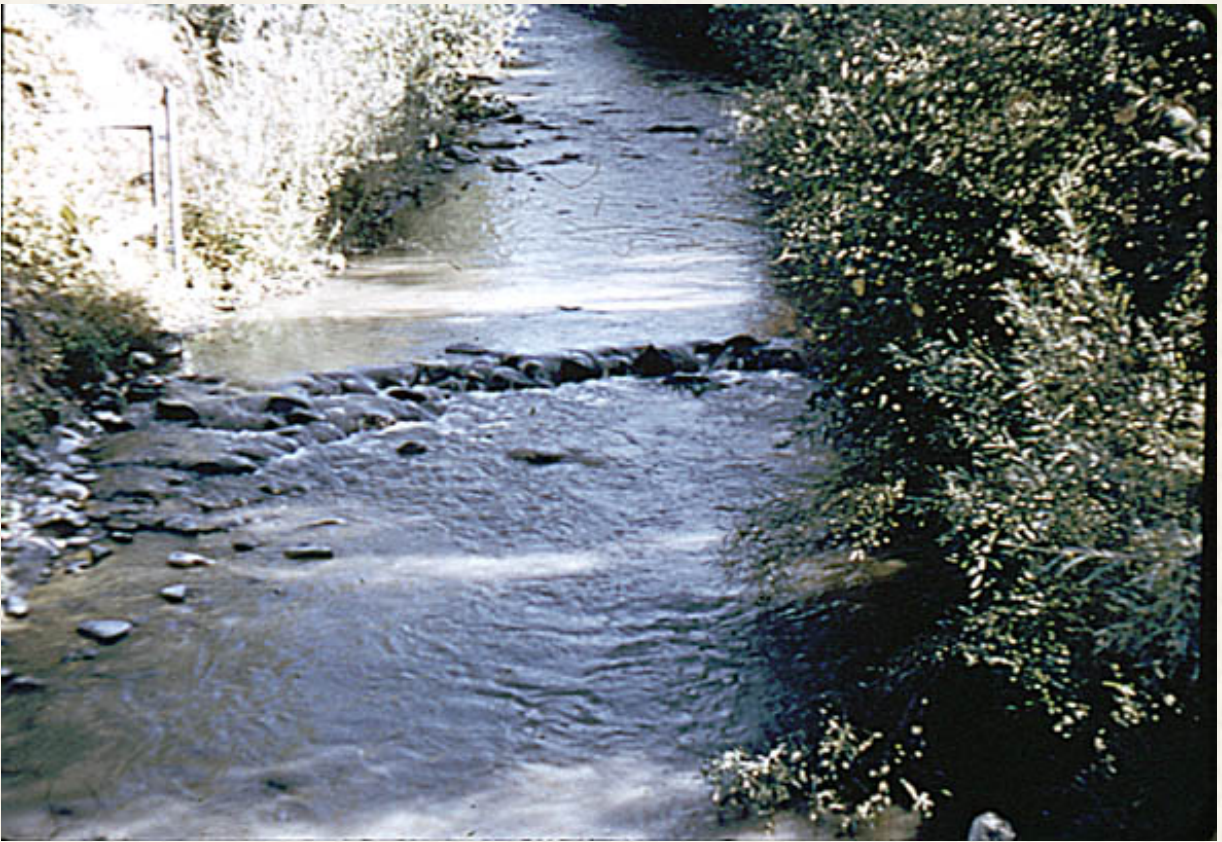
Photo 1185: Upstream from below section 3, Mission Creek near Cashmere, Washington.

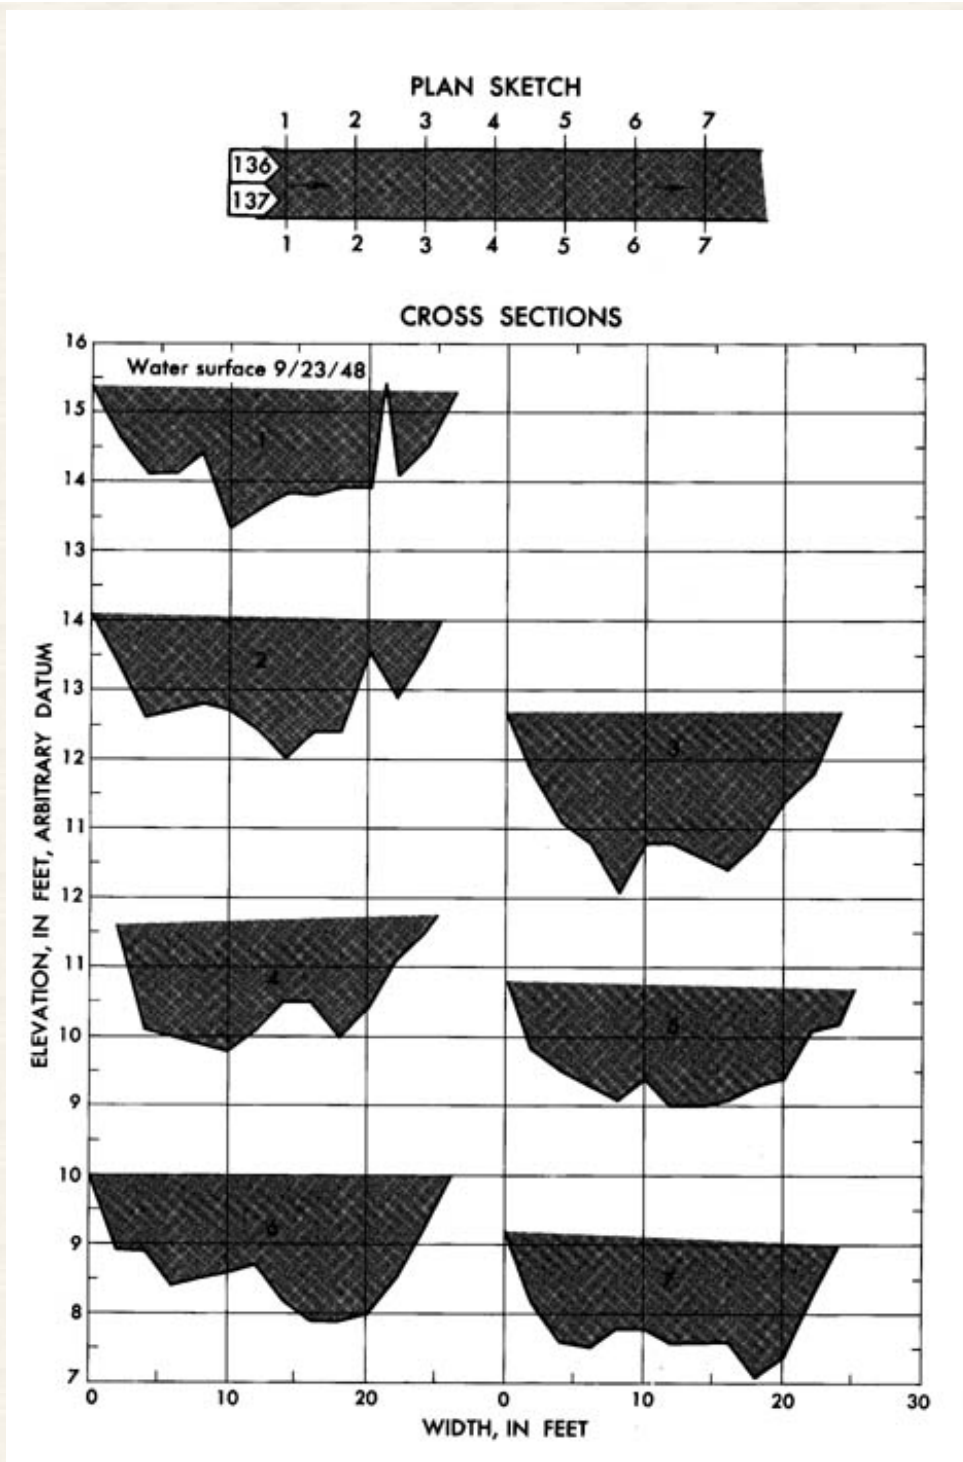
Plan and cross sections, Rock Creek Canal near Darby, Montana.

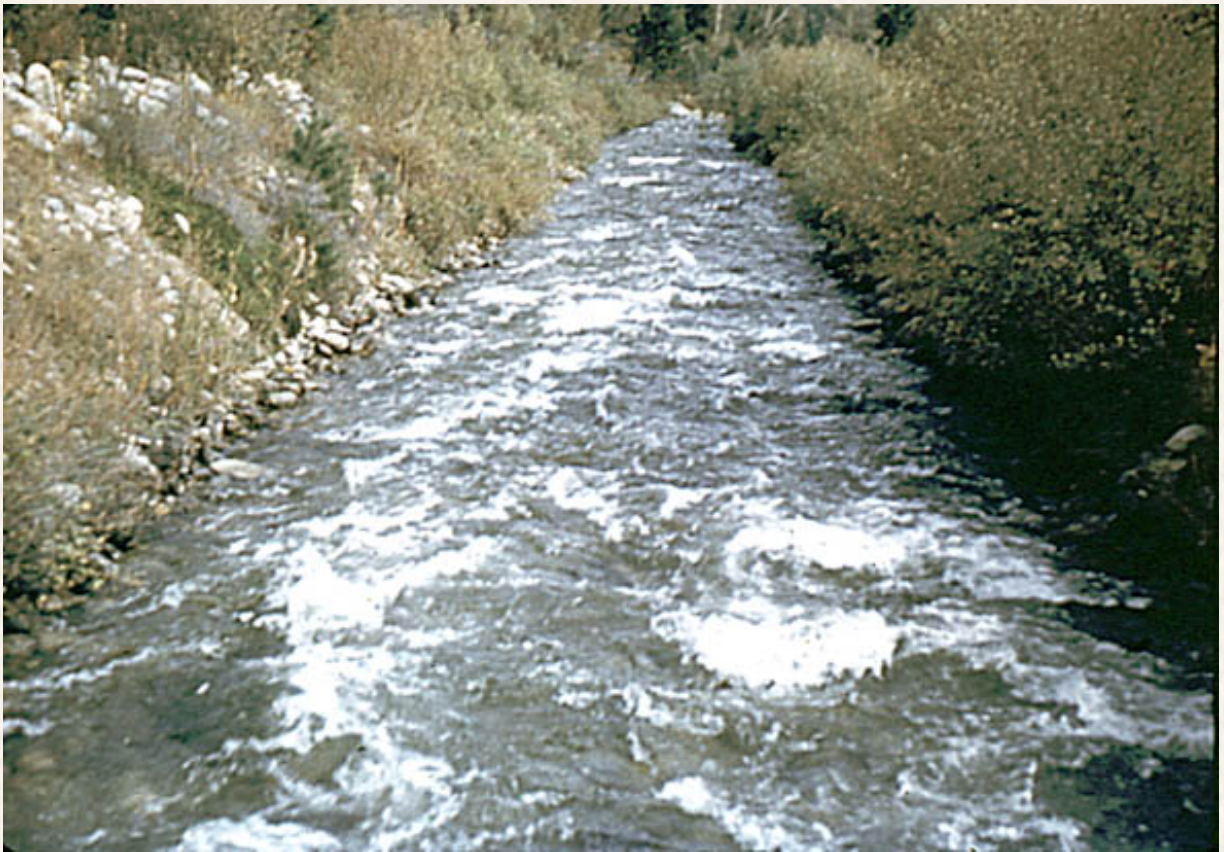
Photo 136: Downstream from above section 1, Rock Creek Canal near Darby, Montana.

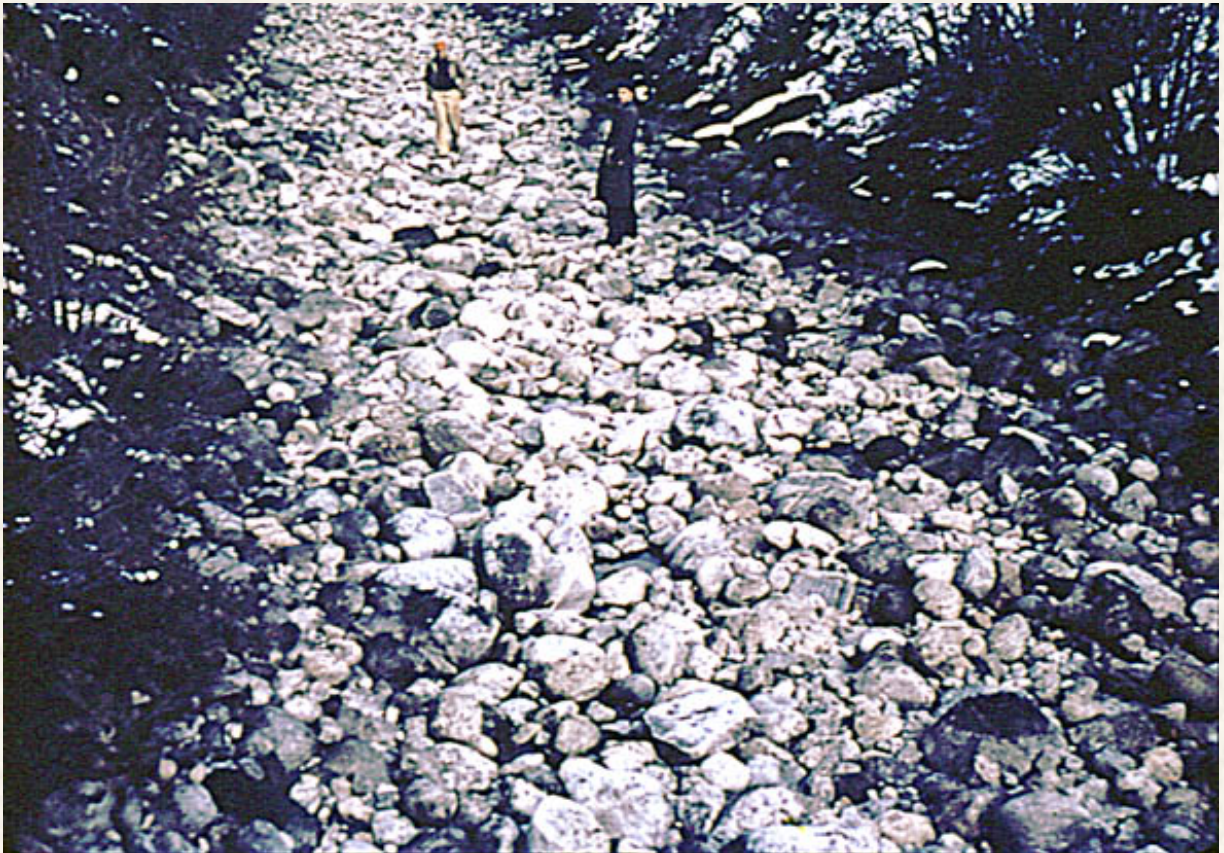
Photo 137: Downstream from above section 1, Rock Creek Canal near Darby, Montana.

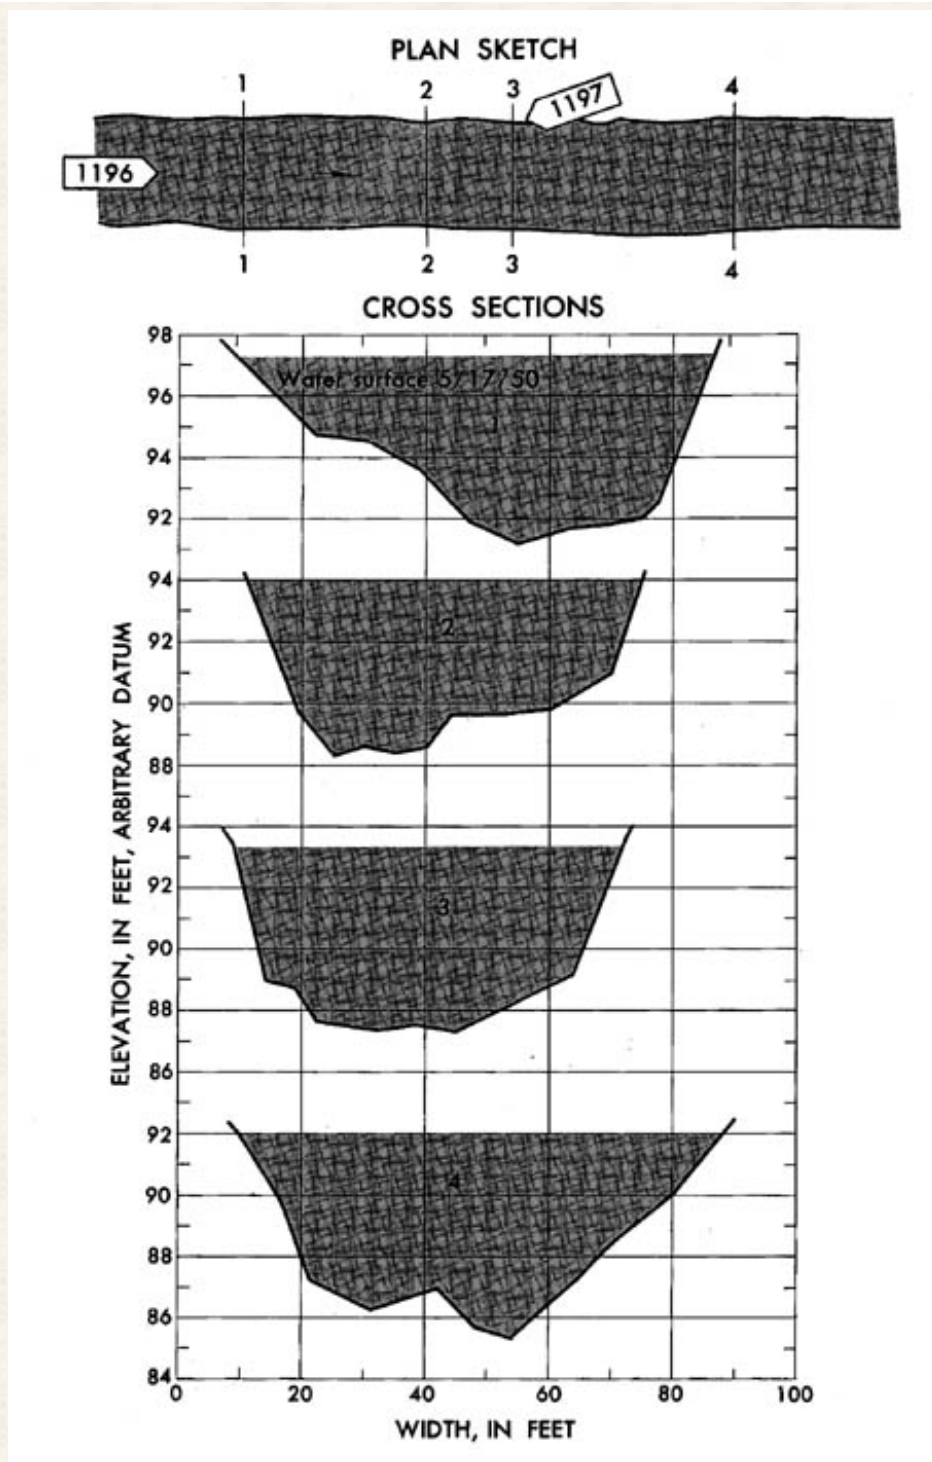
Plan sketch and cross sections, Merced River at Happy Isles Bridge, near Yosemite, California.

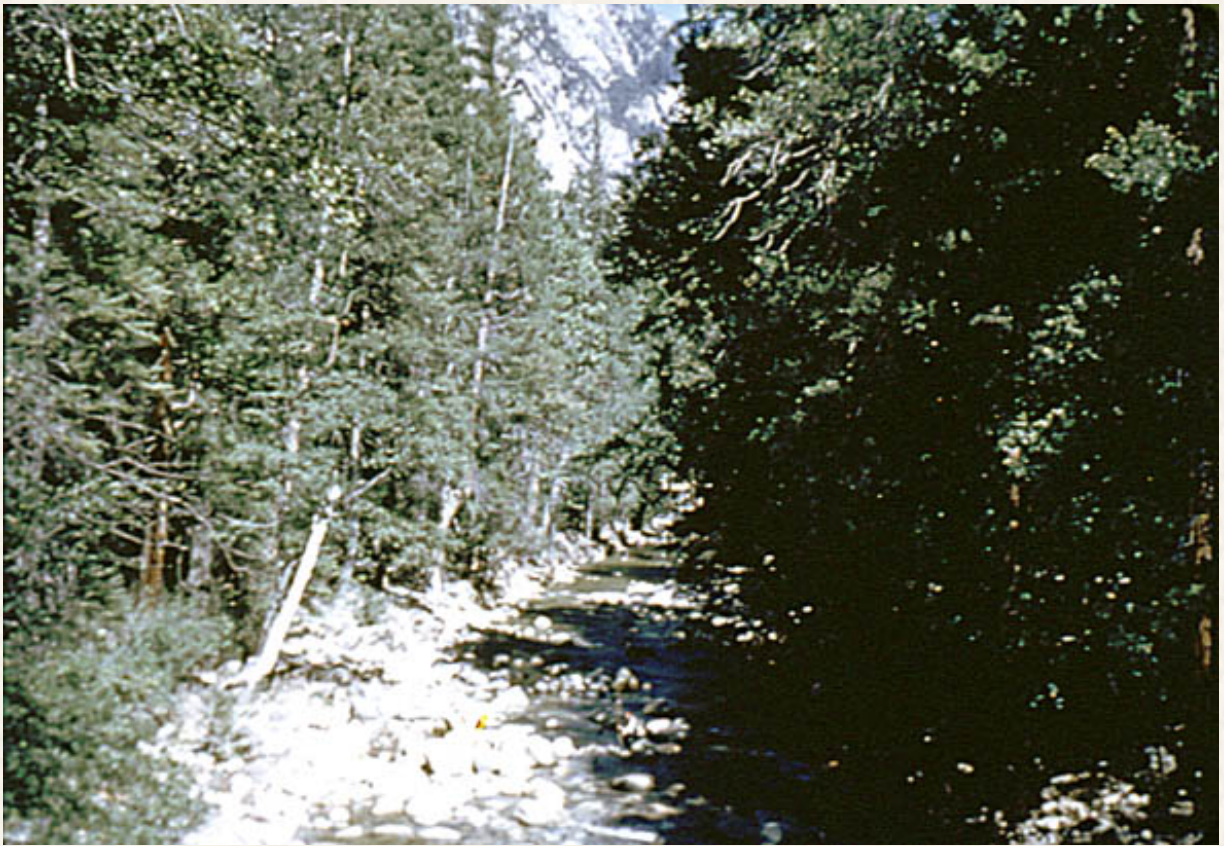
Photo 1196: Downstream from above section 2, Merced River at Happy Isles Bridge, near Yosemite, California

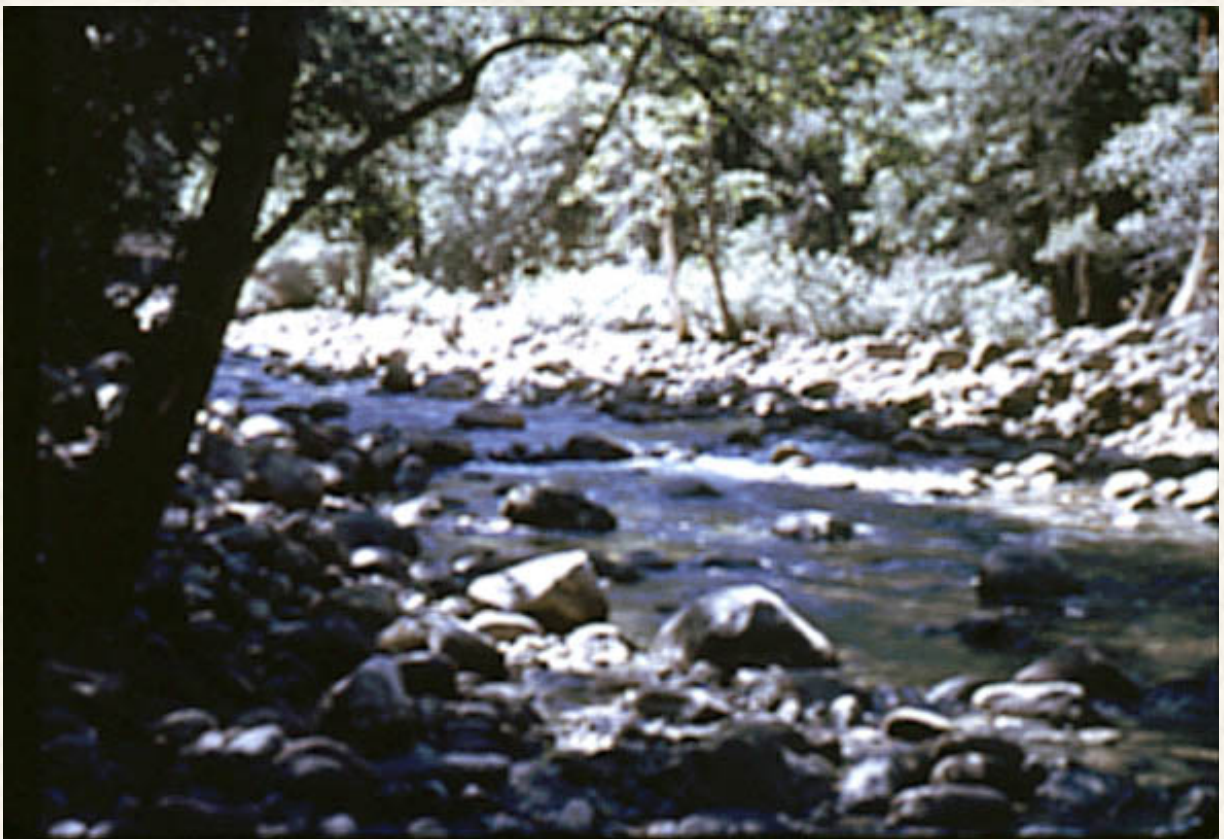
Photo 1197: Upstream from below section 3, Merced River at Happy Isles Bridge, near Yosemite, California.

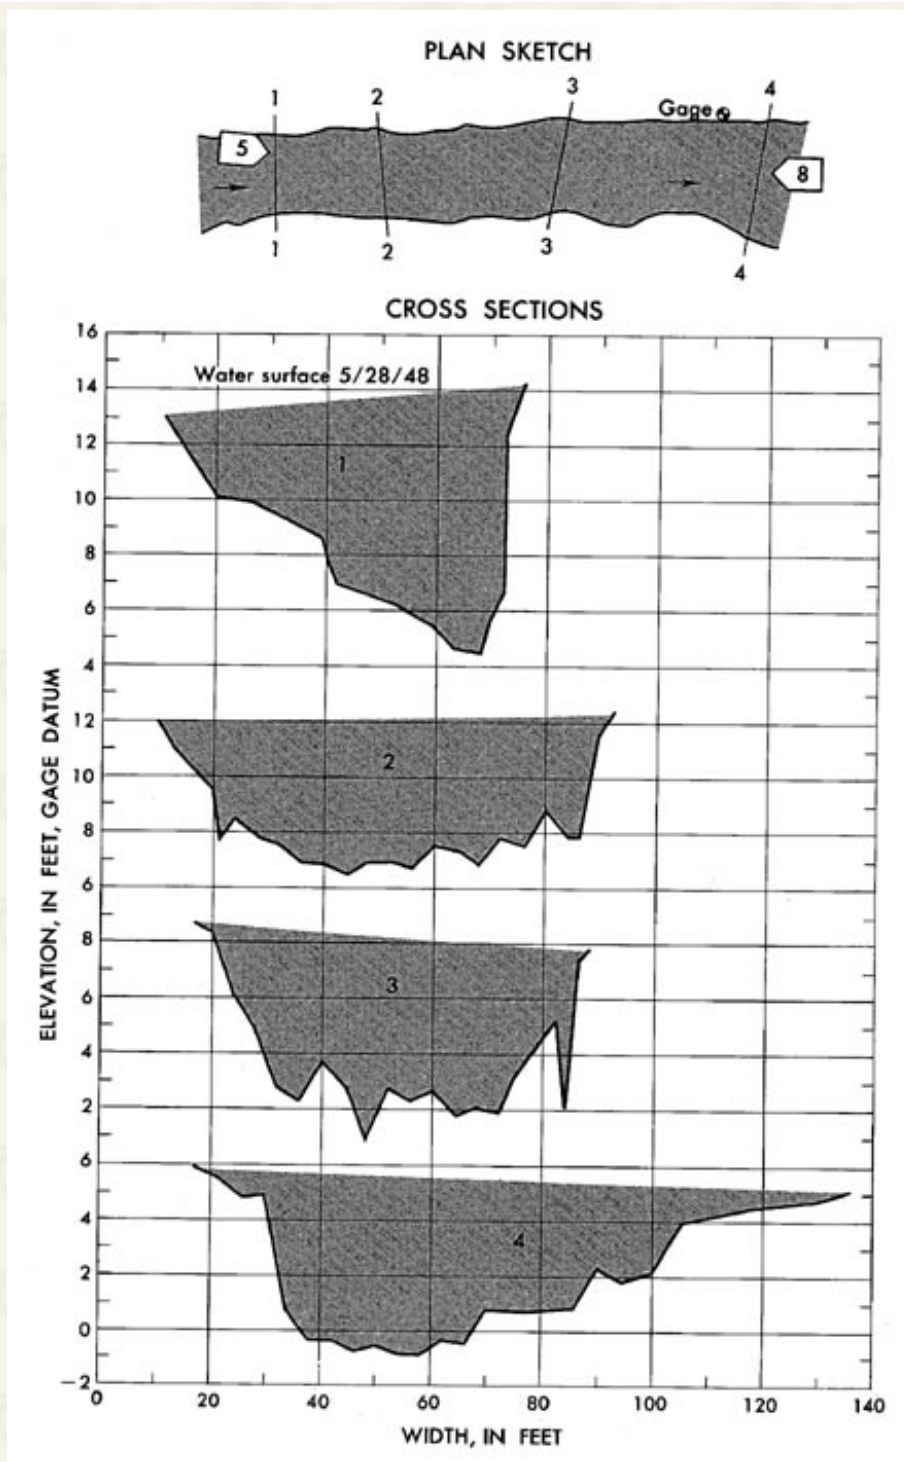
Plan sketch and cross sections, Boundary Creek near Porthill, Idaho.

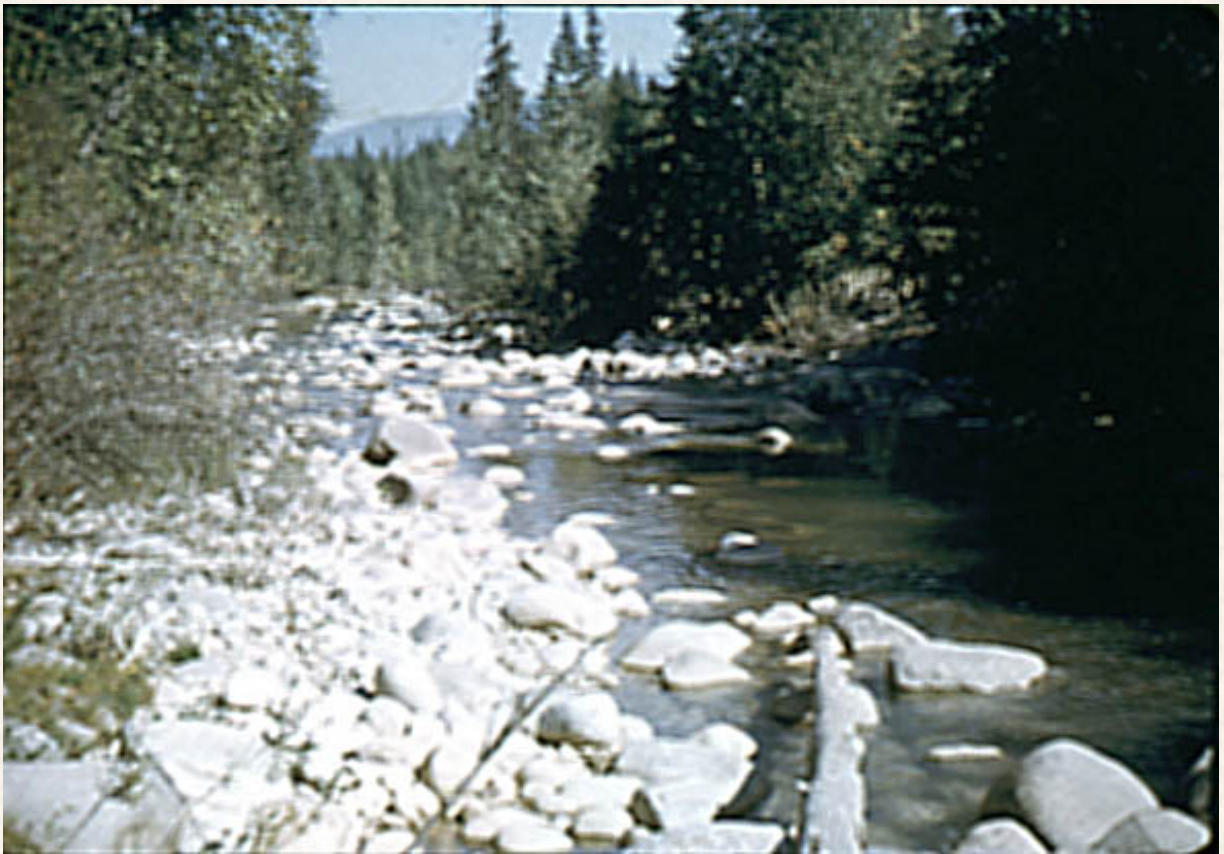
Photo 5: Downstream from left bank above section 1, Boundary Creek near Porthill, Idaho.

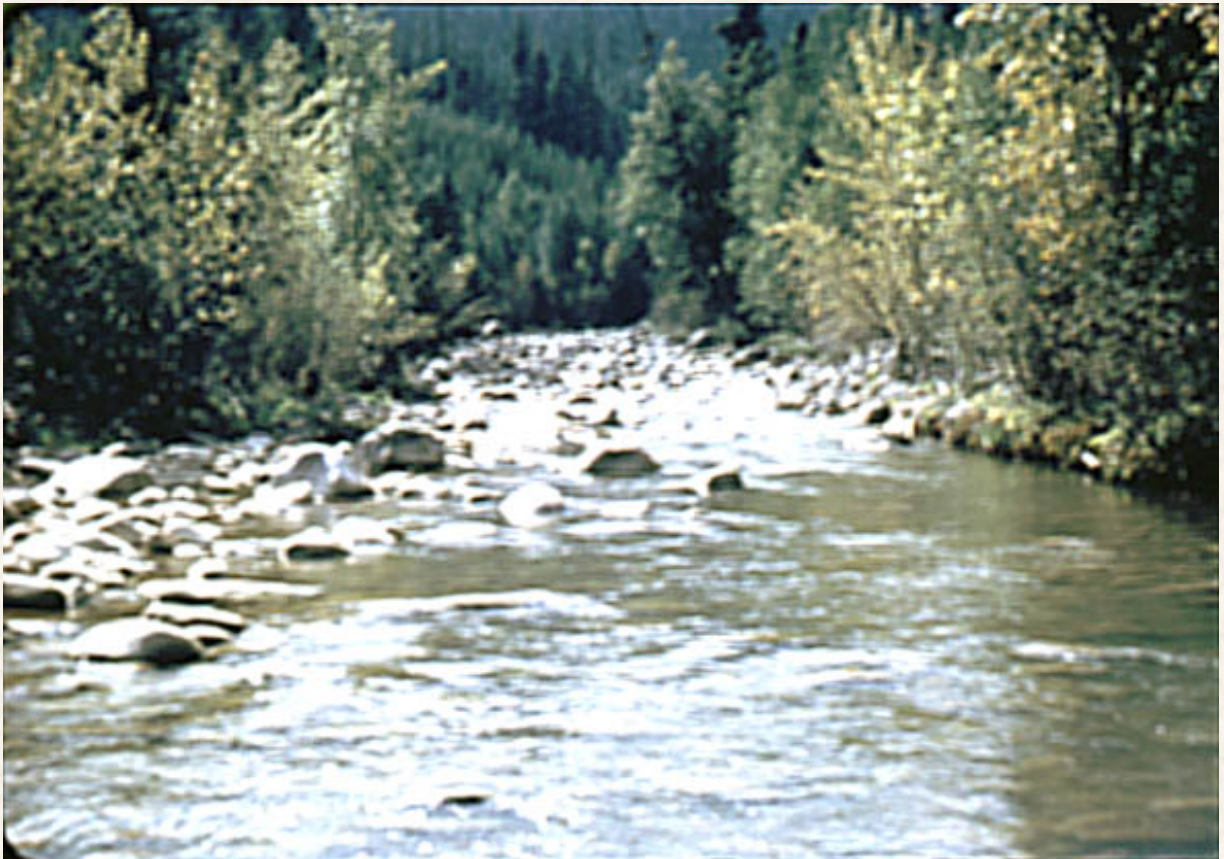
Photo 8: Upstream from below section 4, Boundary Creek near Porthill, Idaho.

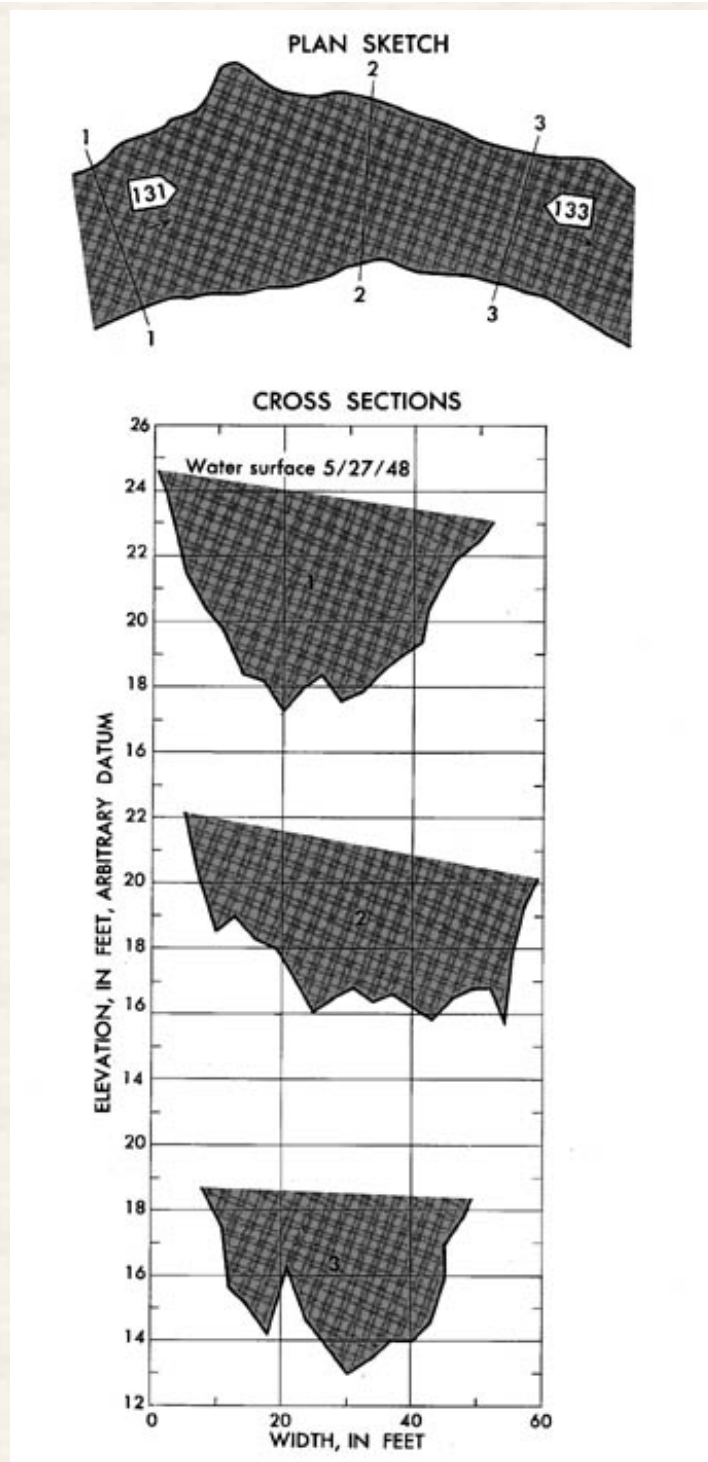
Plan and cross sections, Rock Creek near Darby, Montana.

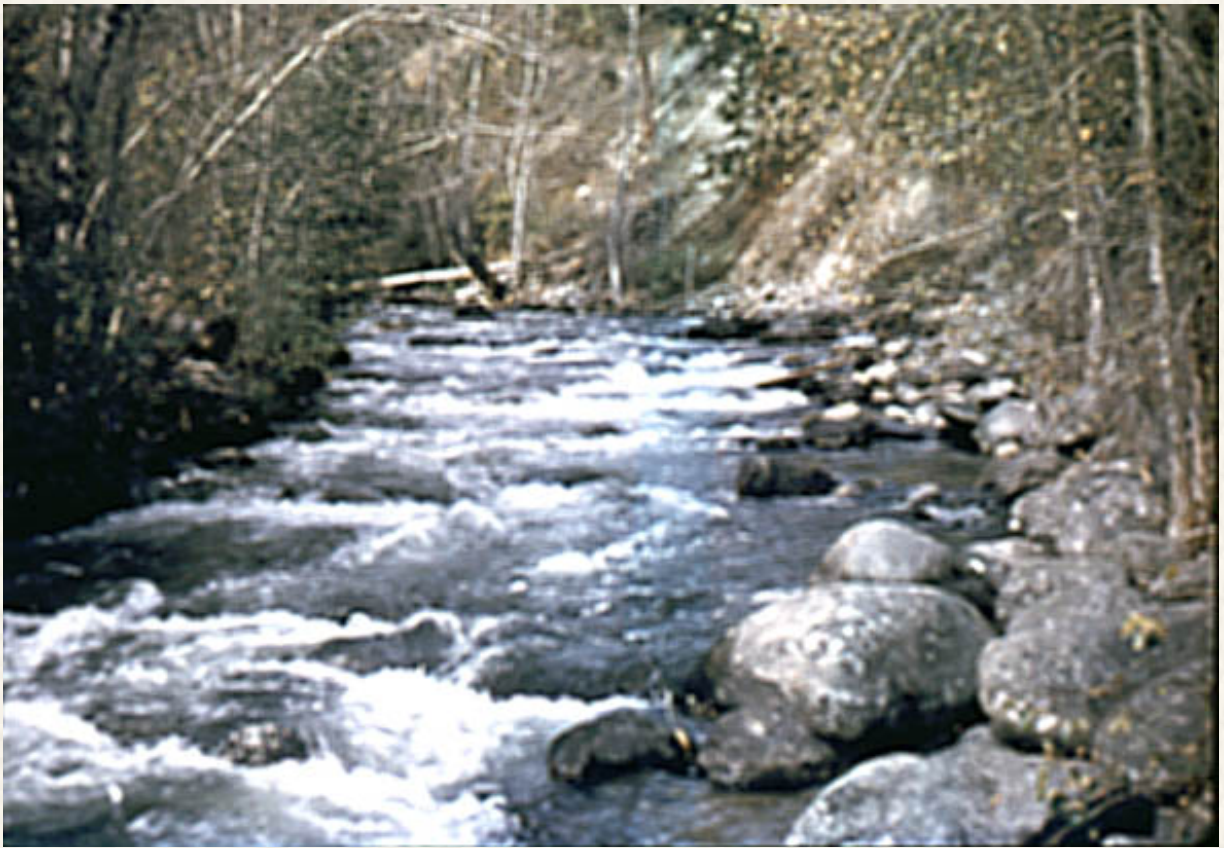
Photo 133: Upstream from below section 3, Rock Creek near Darby, Montana.
