Leaning Tower of Pisa: Behaviour after Stabilization Operations

ABSTRACT: It is well known that the foundations of the Leaning Tower of Pisa were stabilised using the method of underexcavation to reduce the southward inclination of the Tower by about 10 percent in combination with controlling the seasonally fluctuating water table beneath the north side. Having been closed to the public since early in 1990, the Tower was re-opened in December 2001. The paper summarises the response of the Tower during the period of implementation of the stabilisation works. Monitoring of the movements of the Tower has been continuing and the observations obtained since 2001 are presented. It is shown that over the six years between 2003 and 2008 the induced rate of northward rotation of the Tower has been steadily reducing to less than 0.2 arc seconds per year. Similarly the rate of induced settlement of the Piazza. Piezometer measurements close to the north side of the foundation shows that the drainage system has been successful in stabilising the groundwater levels beneath the north side of the Tower's foundation. The paper concludes with a brief discussion on the possible future behaviour of t

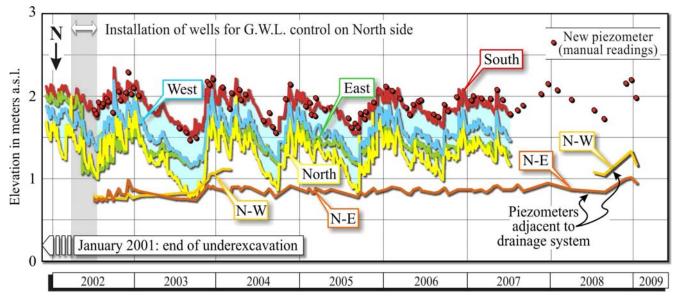
Figure 14. Perched ground water table in horizon "A".

As mentioned previously, the deduced motion of the Tower foundation shown in Fig. 5 led to the conclusion that the seasonal fluctuating water table in Horizon A during intense periods of rain was the main factor responsible for this continuing movement, see Fig. 6. It is also of significance that, apart from these intense periods of rain, the average ground water levels close to the South side of the Tower in Horizon A are 200mm to 300mm higher than those to the North, as shown in Fig. 6. This difference generates a small, but not negligible stabilising moment for the Monument which is so close to falling over. In the autumn and winter, when rainfall events are more intense, the water table rises sharply, reduces the difference in piezometric level and thereby produces southward rotations of the Tower which are not fully recoverable. To minimise this effect it was necessary to eliminate the fluctuations of the water table and, with this objective, a drainage system was installed consisting of three wells sunk on the north side with radial sub-horizontal drains running into them from beneath the north side of the catino, (Fig. 13). The water levels in the wells are controlled by the level of the outlet pipes. The drainage system was implemented in April and May 2002 and lead to a decrease in the pore water pressure as well as a significant reduction in its seasonal fluctuations, as shown in Fig. 14. The installation of this drainage system induced a further northward rotation of the Tower as can be seen in Fig. 15.
